POWER LINE CORRIDOR VEGETATION MANAGEMENT:
CLEARING A PATH TO RELIABLE ELECTRIC SERVICE USING LIDAR

A THESIS PRESENTED TO
THE DEPARTMENT OF HUMANITIES AND SOCIAL SCIENCES
IN CANDIDACY FOR THE DEGREE OF
MASTER OF SCIENCE

By
BRIAN KURINSKY

NORTHWEST MISSOURI STATE UNIVERSITY
MARYVILLE, MISSOURI
OCTOBER, 2013

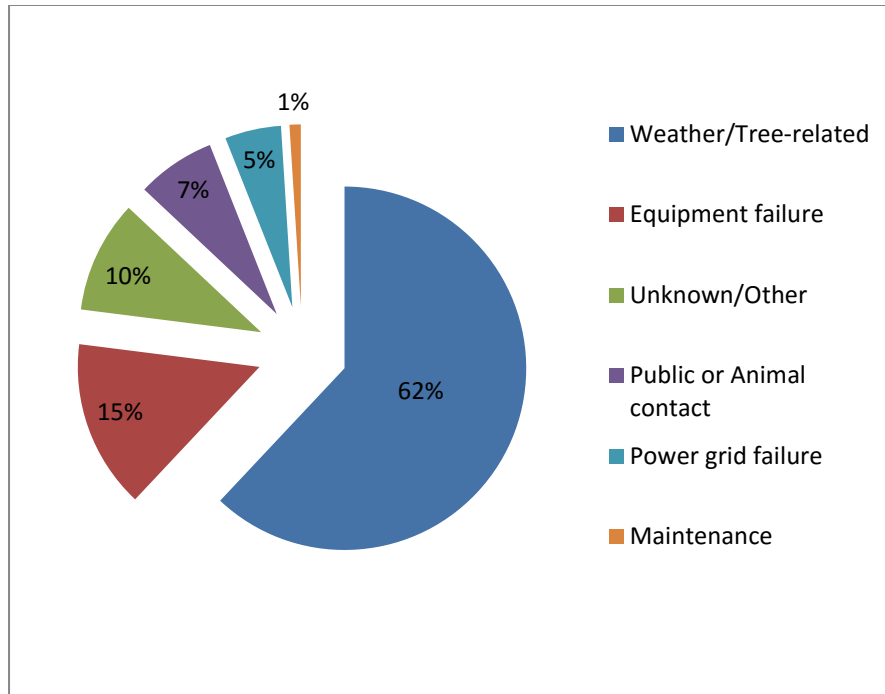
Figure 1.2 – Major causes of power outages in the U.S. (Data according to the Edison Electric Institute)

The cause with the lowest percentage contribution, maintenance, is when a field worker is performing maintenance on some component of the power grid and power has been shut off for employee safety. This is the only type of power outage that is planned.

Power grid failure, with a five percent contribution to causing outages, is when a systematic, widespread failure of the grid occurs due to several different possible factors. Many times the grid is taxed beyond the load it was designed for because of high demand for electricity, and the system simply gives up due to a failure of several components. Utility companies continually face the challenge of satisfying growing energy demands in North America, and it is not always possible to build new power lines due to difficulty acquiring land and environmental approvals (Koop, 2002). Public or animal contact, with a seven percent contribution, can mean that a human or animal has caused some event which, in turn, negatively affects some part of the power grid, causing an outage. Vehicle collisions with support pylon structures are common, and many times damage equipment enough to cause an outage. Contractors or home owners

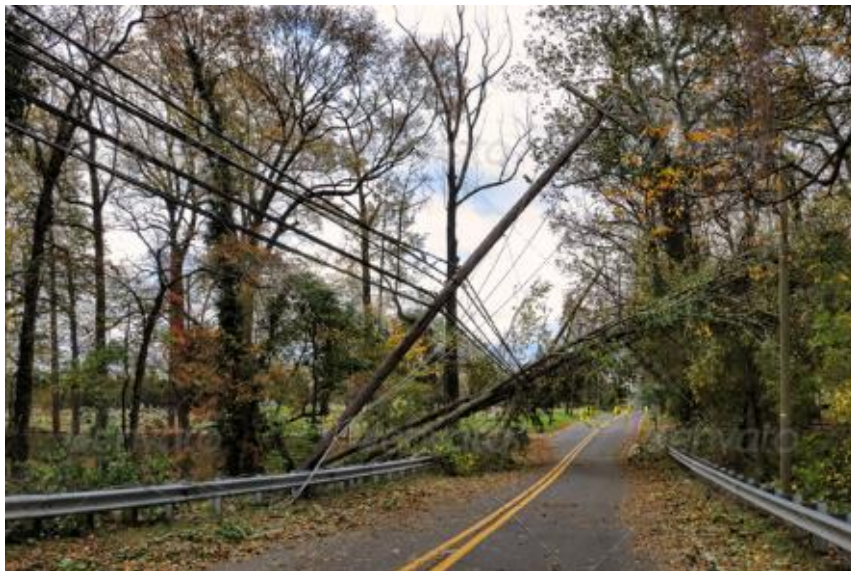
Figure 1.3 – Example of mechanical teardown (Photo by the Knoxville Utilities Board)

breaks mechanical supporting insulators, rips conductors from poles, or breaks and drops conductors (TEES, 2011). This would be any object, usually a tree, which falls into a conductor and tears it down (figure 1.3). Arcs and short circuits occur when a tree bridges the gap between two or more conductors or causes two or more conductors to come into contact with one another (figure 1.4). An example would be a branch falling over two parallel energized phase conductors built on horizontal cross arms. Frequently, a combination of both tear-down and short circuit events occur. In fact, either type of event can occur first, leading to the second. For example, lines torn down by trees (mechanical tear-down) can cause conductors to arc when they hit the ground, creating an electrical short circuit. Conversely, an electrical short circuit can burn conductors in two, and cause them to fall to the ground (TEES, 2011). TEES has determined that for electric distribution feeder lines, mechanical tear-down represents the primary cause of vegetation related outages.

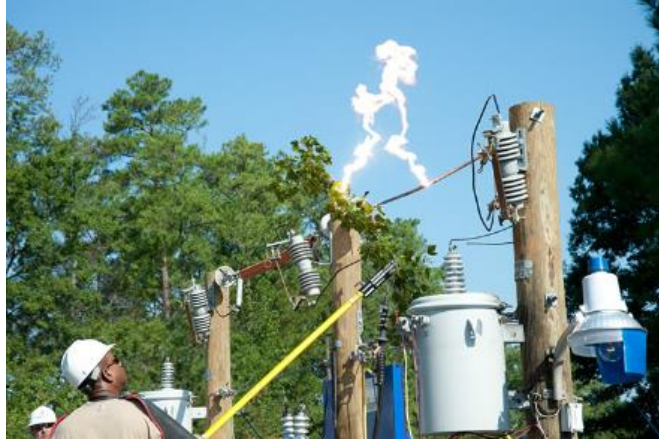
*Figure 1.4 – Example of an arc caused by a tree limb
(Photo by the Knoxville Utilities Board)*

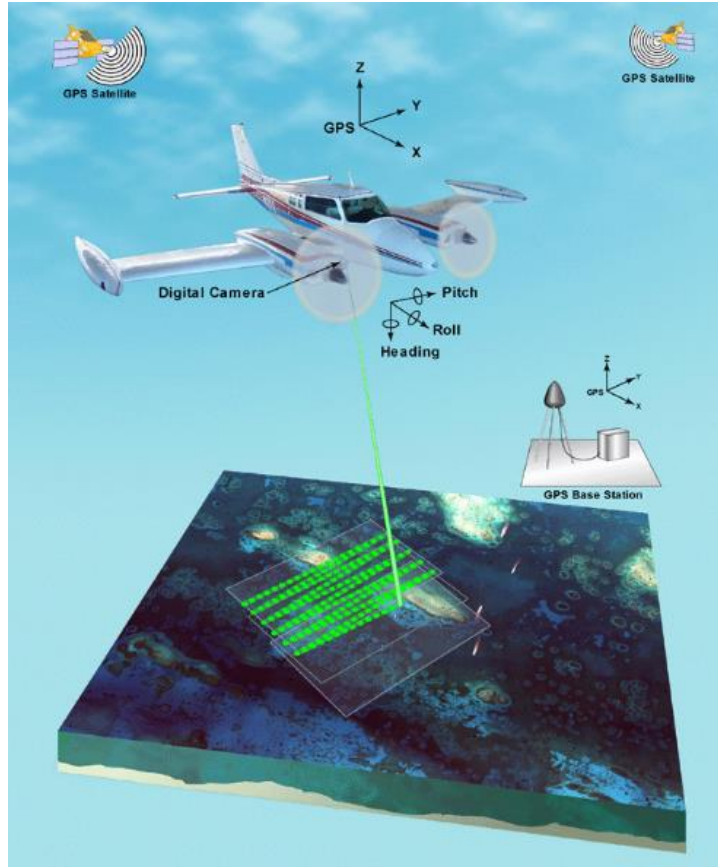
Figure 2.1 – Example of a fixed wing LiDAR platform collection
 (<http://coastal.er.usgs.gov/hurricanes/ivan/lidar/lidar.html>)

LiDAR collection systems use a powerful laser that includes a transceiver and receiver, a GPS receiver, an inertial measurement unit (IMU), and a scanner. The laser typically produces a wavelength of light between 532 and 1550 nanometers, but varies depending on platform and application. The transceiver emits pulses and return pulses are picked up by the receiver. The GPS receiver reports the location of the sensor platform in the form of latitude, longitude, and elevation. The inertial measurement unit measures the attitude of the sensor attached to its platform. Attitude is known as the roll, pitch, and heading of the platform. Roll is rotation about the y axis, pitch is rotation about the x axis, and heading is rotation about the z axis, also known as yaw. The platform can be a helicopter, fixed wing aircraft (figure 2.1), motor vehicle (figures 2.2 and 2.3), or even a stationary terrestrial setup (figure 2.4). Typically, a terrestrial scanner does not have an IMU. A mirror attached to the scanner spreads the pulses across the surface the system is mapping (Young, 2011).

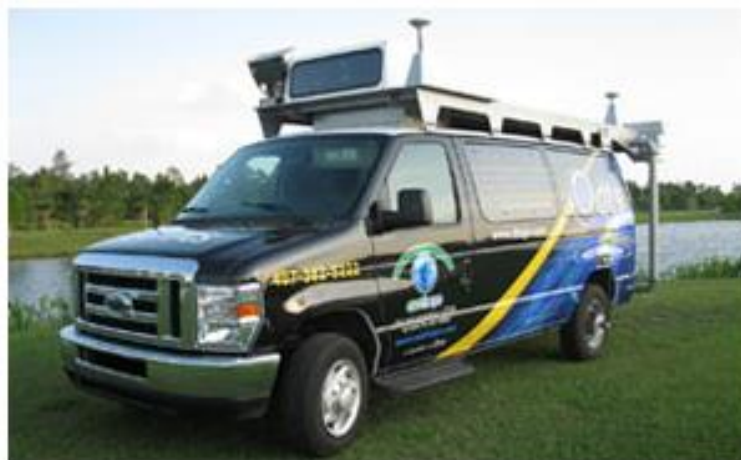
Figure 2.2 – Example of a mobile LiDAR sensor mounted atop a van (Photo by Earth Eye, LLC)

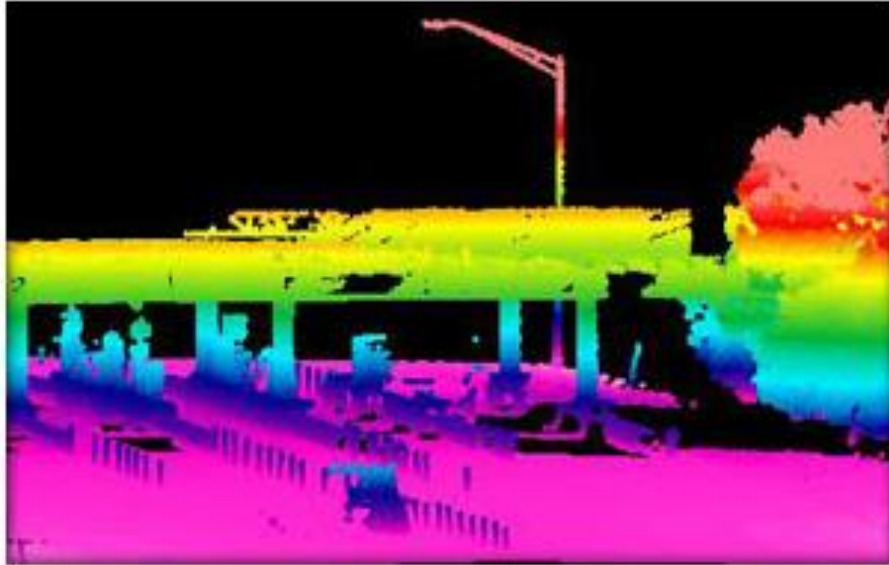
Figure 2.3 – Example of mobile LiDAR data collected near a tollbooth (Image by Earth Eye, LLC)

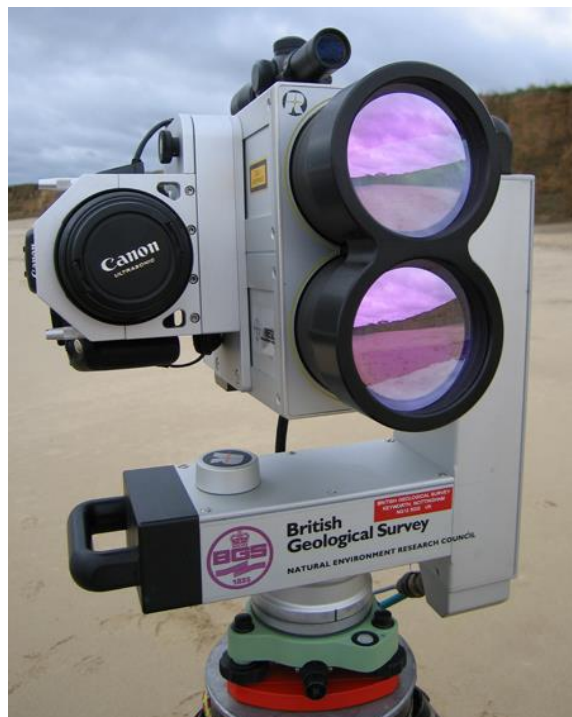
Figure 2.4 – A stationary terrestrial LiDAR system (British Geological Survey. Non-commercial use license - https://www.bgs.ac.uk/about/copyright/non-commercial_use.html)

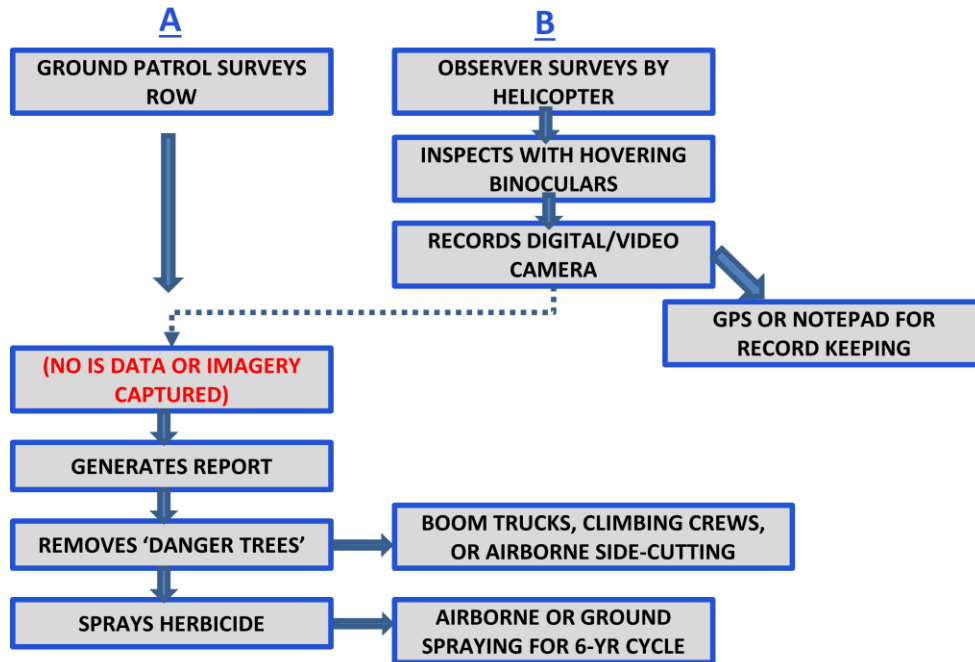
Figure 2.5 – Hydro One’s workflow

Historically, manual inspection methods have been used by a majority of utility companies to manage rights-of-way (ROW) vegetation (Young, 2011). These mostly include foot and/or vehicle patrols and aerial patrols by helicopter while using various tools and techniques for measuring distances between vegetation and power lines (Mills et al., 2010). Like many utility companies, American Electric Power (AEP), based in Columbus, Ohio, has used an aerial patrol technique involving both human visual inspection and video to prioritize vegetation work. Jobes et al. (2008) argued these can be great processes, but they can be subject to human error. The amount of estimation certainly contributes to the error. Another utility company, Hydro One, based in Ontario, Canada, has also historically used ground patrol surveys and helicopter surveys to manage transmission line right-of-way. Below is an example of the company's workflow for managing vegetation (figure 2.5).

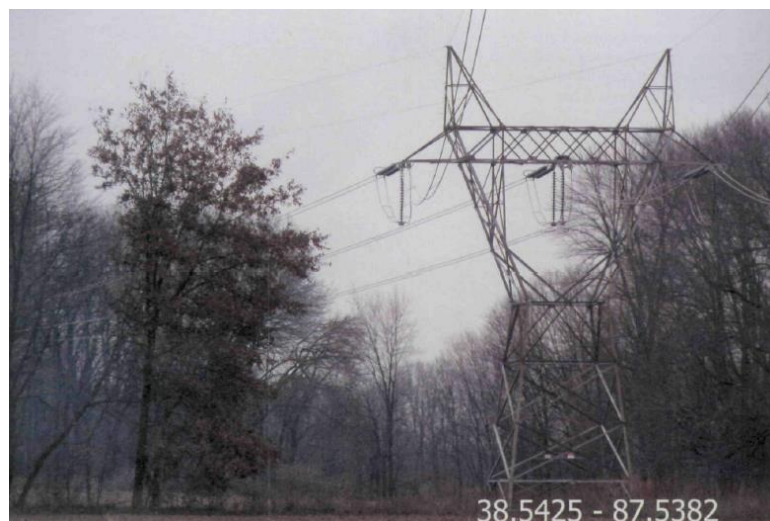
Figure 2.6 – A hazardous tree missed by AEP’s aerial survey but detected with LiDAR (Photo by AEP)

methods had found. Figure 2.6 shows an example of a hazardous tree missed by prior aerial survey, with GPS coordinates confirmed by handheld tools used by the ground crew (Jobes et al., 2008).

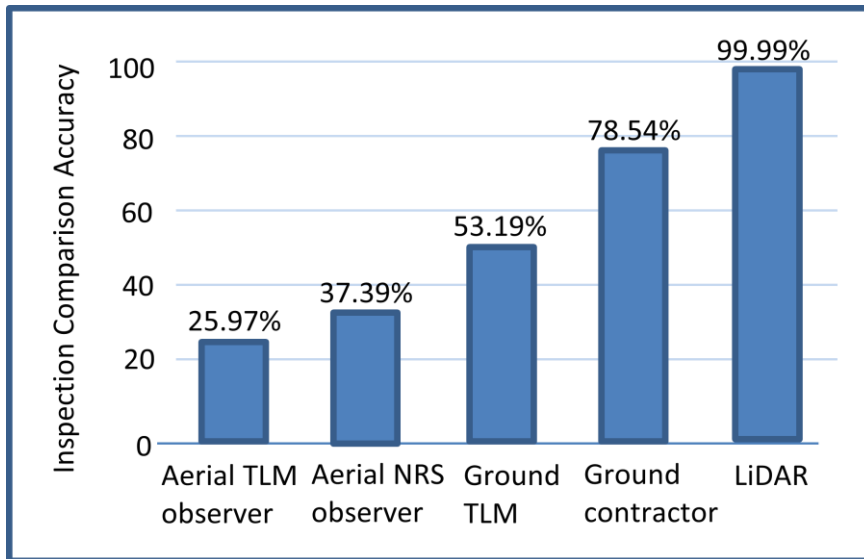
Figure 2.7 – Comparison of “danger tree” grow-in inspection techniques

Danger Tree Grow-In Inspection Method Comparison		
Method	Shared points	Unique points for first method
Aerial TLM vs. Ground contractor	17	61
Aerial TLM vs. Ground TLM	123	81
Aerial TLM vs. aerial NRS	191	14
Ground contractor vs. Aerial TLM	17	603
Ground contractor vs. Ground TLM	63	372
Ground contractor vs. Aerial NRS	28	602
Ground TLM vs. Aerial TLM	123	321
Ground TLM vs. Ground contractor	63	117
Ground TLM vs. Aerial NRS	93	273
Aerial NRS vs. Aerial TLM	191	48
Aerial NRS vs. Ground contractor	28	114
Aerial NRS vs. Ground TLM	93	138

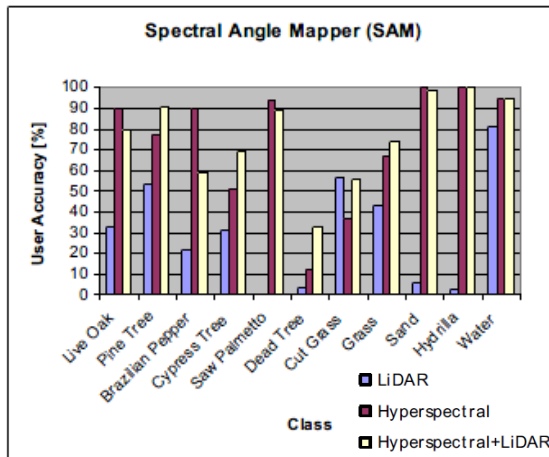
Figure 2.8 – Individual accuracies for the spectral angle mapper

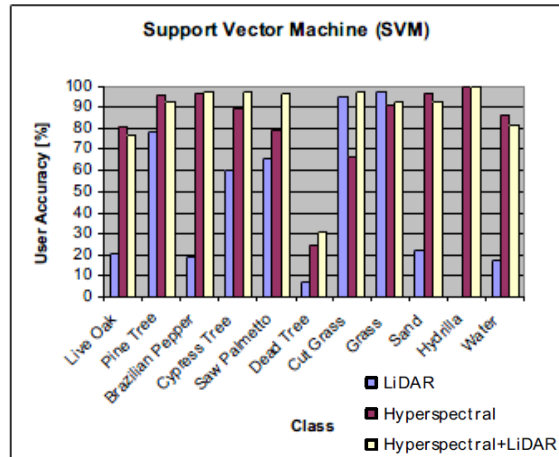
Figure 2.9 – Individual accuracies for the support vector machine

SVM	Overall Accuracy	Kappa Coefficient
LiDAR	54.24%	0.4859
Hyperspectral	83.26%	0.8039
Hyperspectral + LiDAR	91.75%	0.903

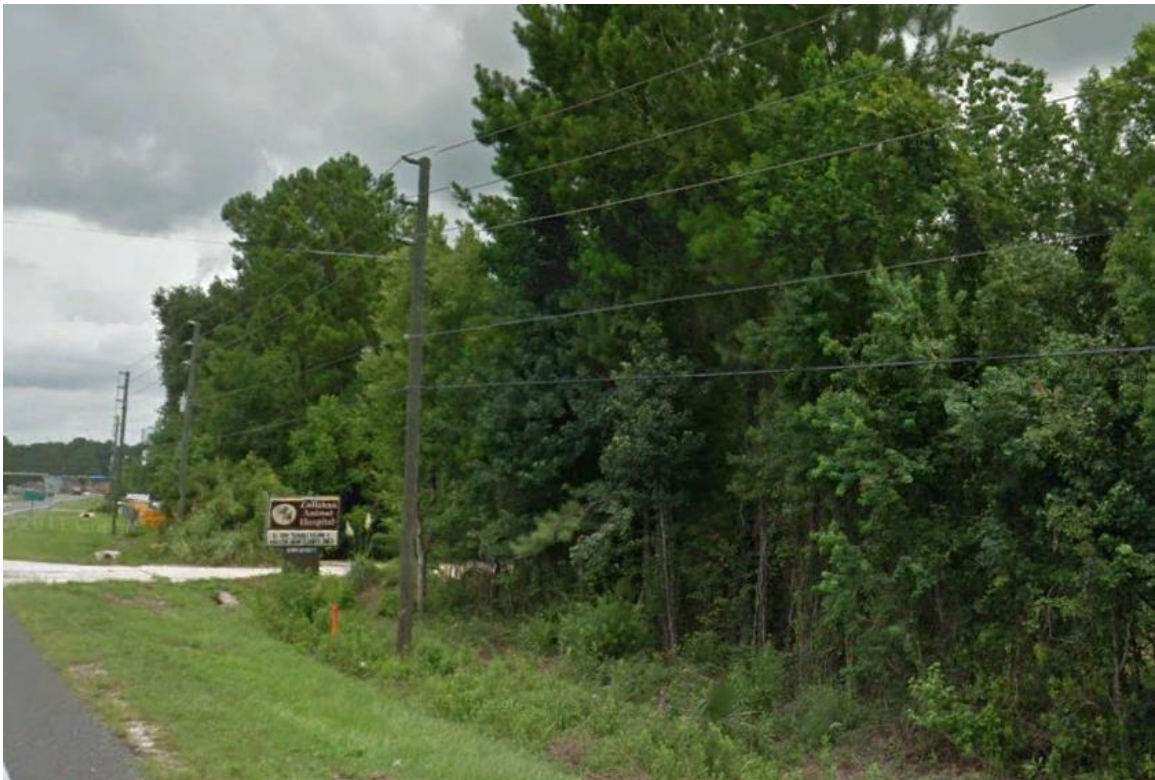
Figure 3.2 –Power lines found in the study area (GoogleEarth Pro).

These distribution lines are characteristic of those many of us might see while driving around town, perhaps to and from work or the grocery store (figure 3.2). Distribution lines, sometimes referred to as ‘feeder lines’ in the utility industry, distribute electricity from substations to residential neighborhoods and businesses. Figure 3.2 was created by randomly choosing a location along the study area power line corridor and going into “street view” in Google Earth. It is immediately apparent there is vegetation growing in close proximity to the power lines, which makes this area a good one for the type of analysis that will be conducted in this study.

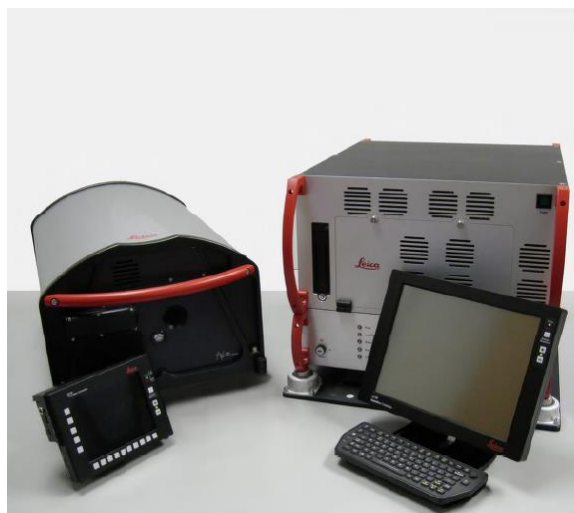
Figure 3.3 – Leica Geosystems ALS60 LiDAR system components (Photo by Leica Geosystems. Terms of Use - http://www.leica-geosystems.com/en/Web-Site-Legal_1540.htm#6)

Data Format	LAS (.las)
Sensor	Leica Geosystems ALS60
Platform	Cessna 207 Single Engine Aircraft
Sensor Mode	Linear
Coordinate System	NAD 1983 State Plane Florida East – FIPS 0901 – Feet (2236)
Collection Date	5/30/2012
Point Density	35 points/meter ²
Vertical/Horizontal Accuracy	< 15 centimeters

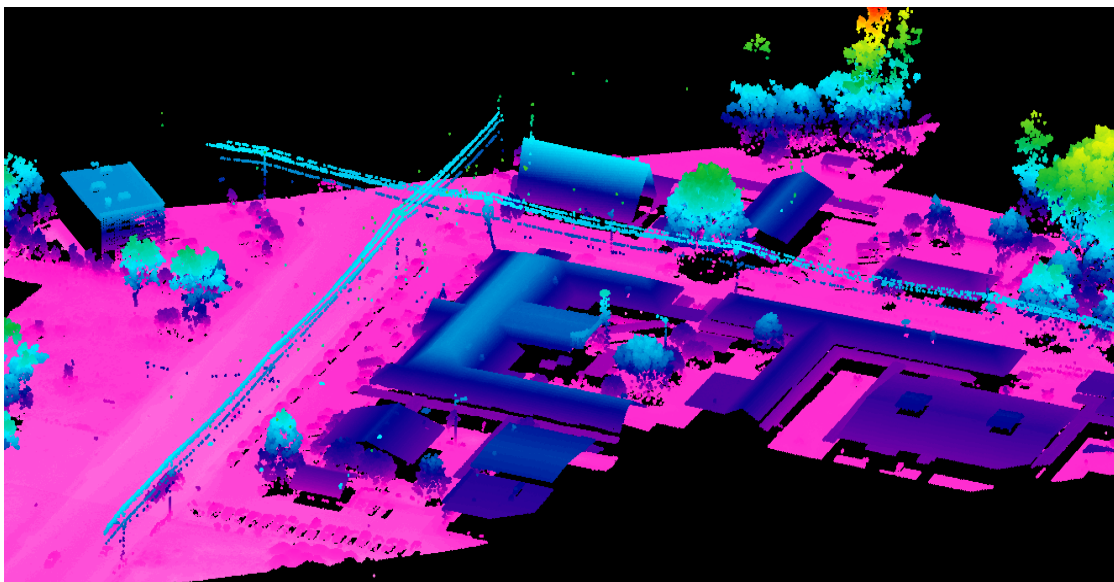
Figure 3.5 – 3D view of the LiDAR source data, colored by relative height

A sample of the LiDAR data used for this study is shown in figure 3.5. The point cloud is colored by relative height, and it is apparent that power line conductors, most support poles, trees, and buildings are clearly visible. This is due to the relatively high point density of the data at an average of 35 points per meter². This level of point density is ideal in order for conductor wires to appear in the point cloud, along with several levels of tree canopy.

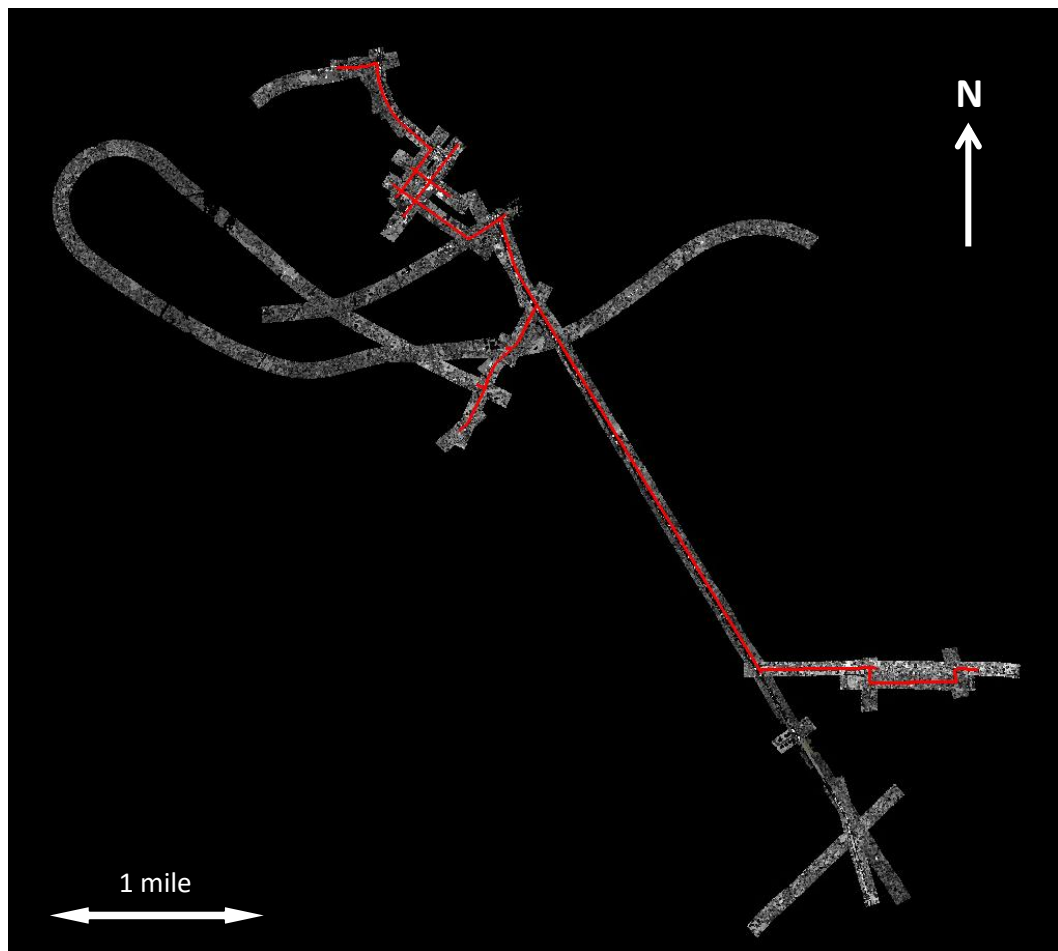
Figure 3.6 – The source LiDAR data displayed as an 8-bit intensity image

Figure 3.6 shows the results of the LiDAR collection over the entire study area. The data are displayed in greyscale according to intensity, which means that if a laser pulse is strongly reflected from a feature it will display more toward the white end of the scale, and less reflectance from a feature will display more toward the black end of the scale. The data are displayed this way only to allow the vector data representing the conductors to stand out, and this study will not be concerned with intensity values. The vector data were created using a process that will be explained later.

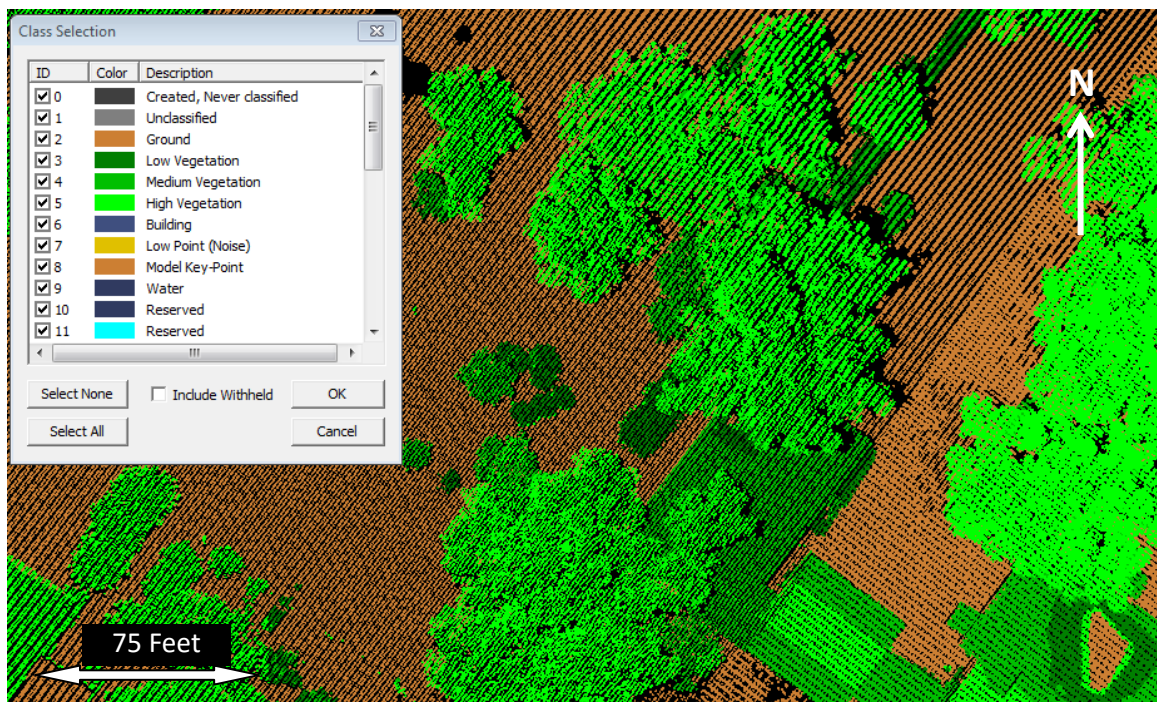
Figure 3.7 – Source LiDAR data colored by class

For the preprocessing, a ground filter was run on the LiDAR data to assign the ground points to class 2. In this case, the LiDAR data vendor left out the building class (6) to speed up processing time and reduce labor, as the data were collected at no charge to the customer. The buildings represented in the LiDAR data were classified as one of the vegetation classes as a result. Figures 3.7 and 3.8 show a sample of the source data classified as obtained.

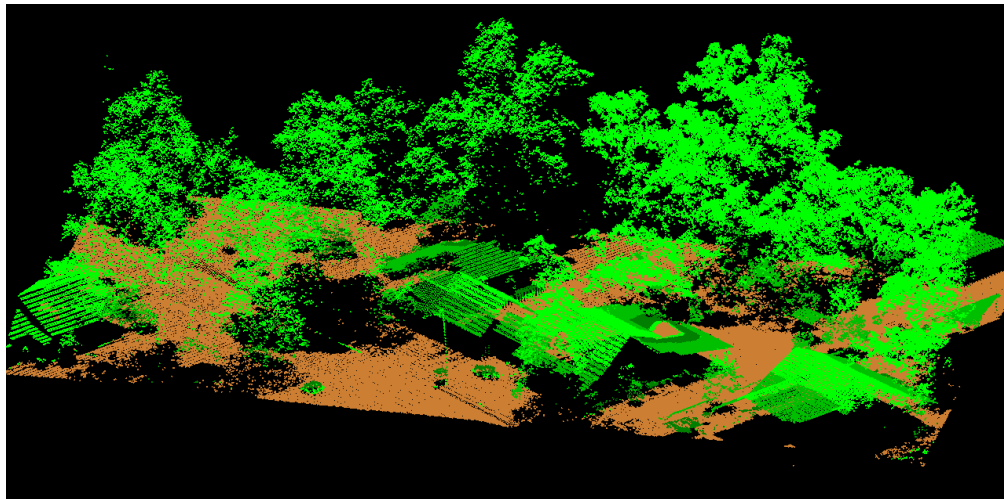
Figure 3.8 – Source LiDAR data colored by class (3D view)

The absence of the building class and the fact that buildings have been lumped into three vegetation classes are not necessarily a problem. For this analysis, the most critical detail regarding classification of the data is that points representing conductors are in a different class than vegetation or any other classes. However, they too have been put in the vegetation classes (figure 3.9). The process of conductor classification is a necessary step, and will be explained later.

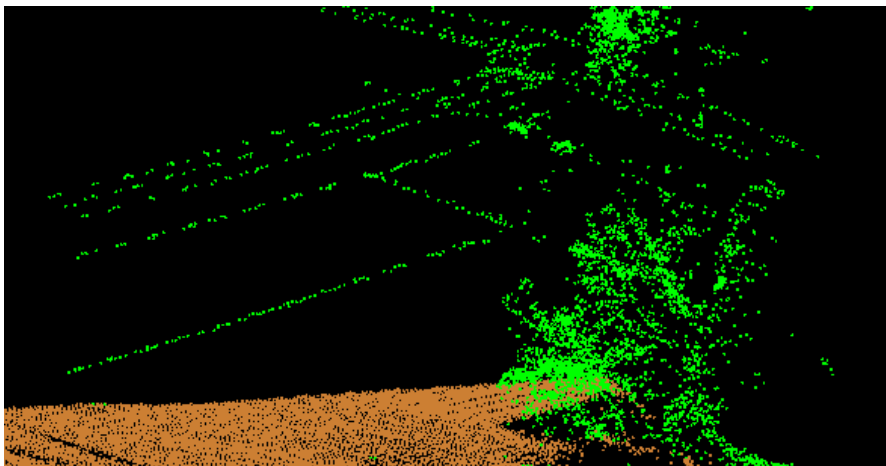
Figure 3.9 – Conductors in the high vegetation class (3D view)

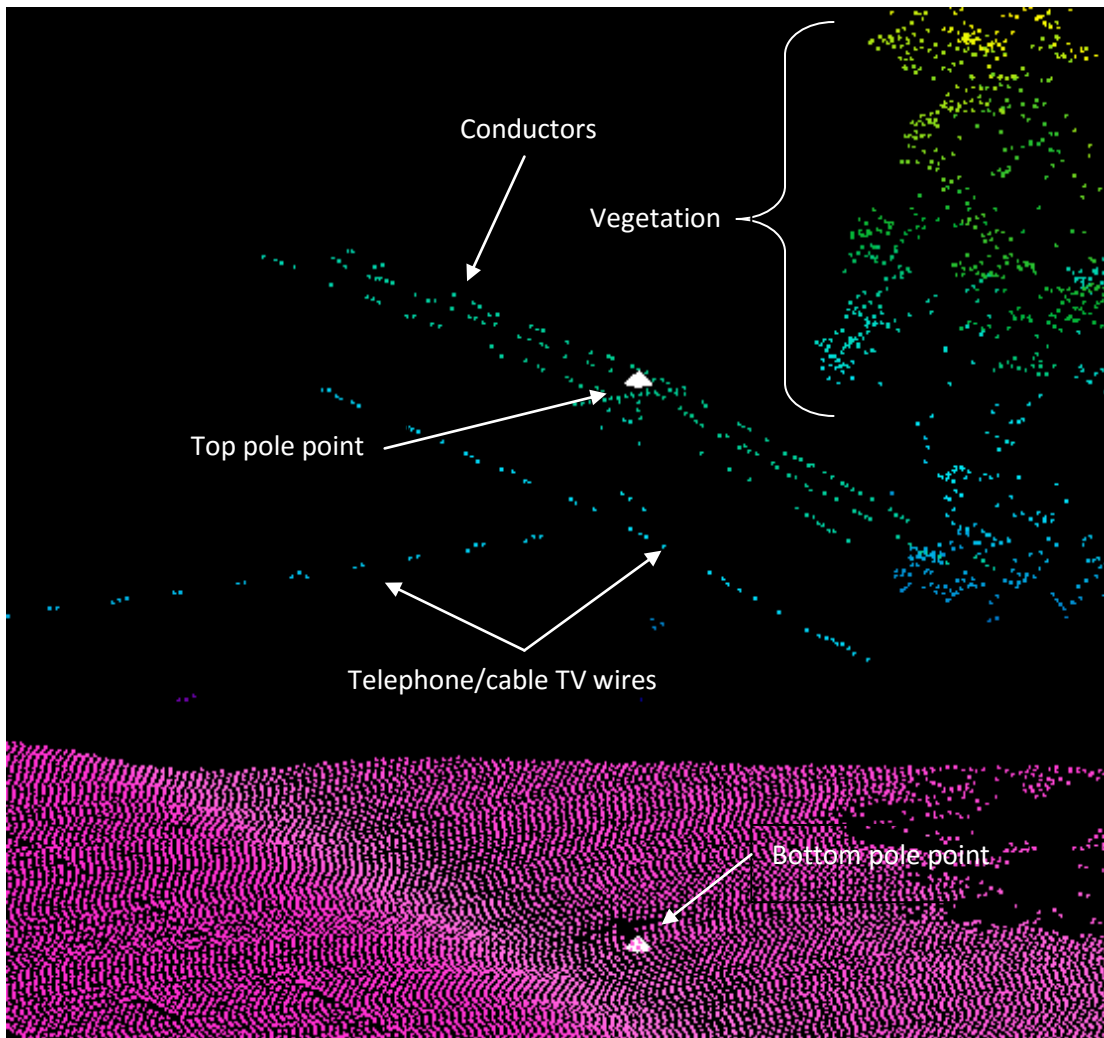
Figure 3.15 – The initial top and bottom pole points

While in profile mode, the Power Line tool became available and was opened. Next, the view was switched to 3D so the tops of poles could be accurately identified. For each pole, a white point was placed at the top, and the Power Line tool placed a white point directly (vertically) below it, lying on the lowest LiDAR point beneath (figure 3.15). When this looked satisfactory the Add Tower command was invoked, and the pole vector was created (figure 3.16). This process was repeated until all desired support pole vectors were created.

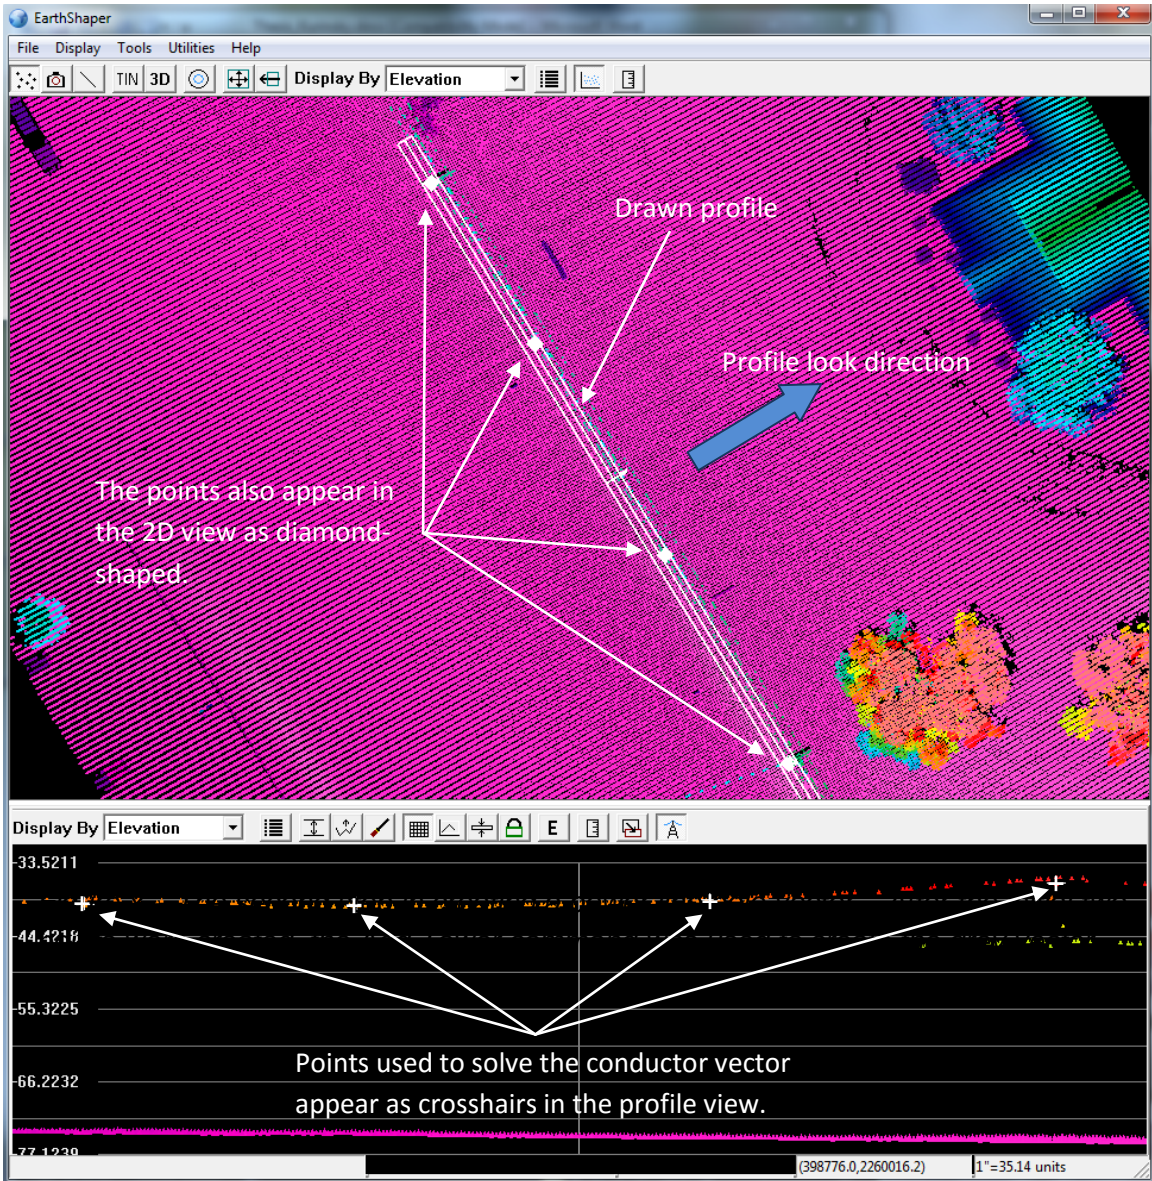
Figure 3.17 – Points used to solve the conductor vector

Each span between poles was visited using the profile tool. To ensure only one conductor (or phase) was being vectorized at a time, the profile width had to be narrowed so other phases did not appear in the view. With a single phase of a span in the profile view, the Define Power Lines tab of the Power Line tool was opened. To create a vector out of the LiDAR points that represented the conductor, a minimum of four points had to be placed on it in the profile view (figure 3.17). The software will accept more, but four were usually satisfactory. After at least four points were placed on the conductor, a “best fit” algorithm was run to create a vector from the LiDAR points. It was a necessary step to collect the poles first, because the conductor vector solving algorithm will not work without them. Figure 3.18 shows a solved conductor (dashed line) that could be accepted or rejected. Figure 3.19 shows an accepted conductor vector (solid line).

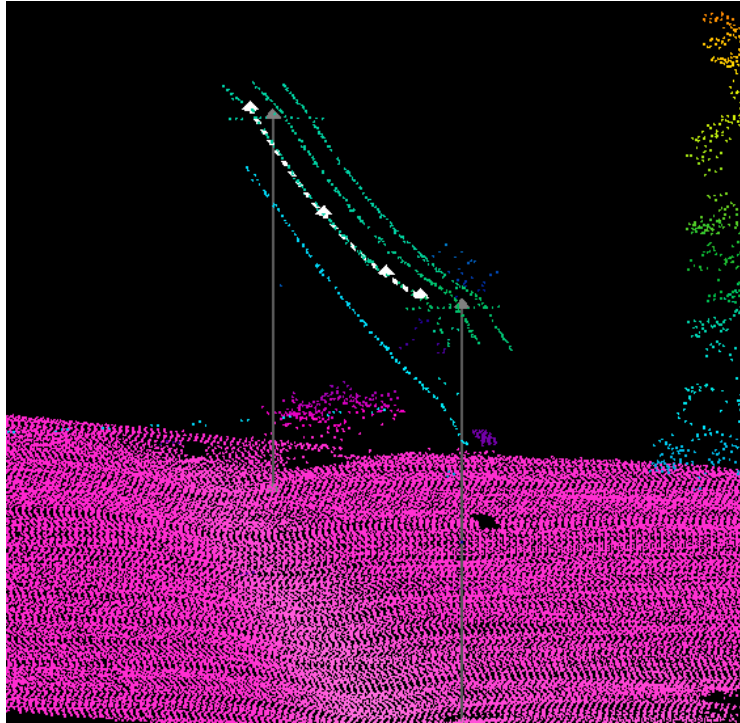
Figure 3.18 – Solved conductor vector

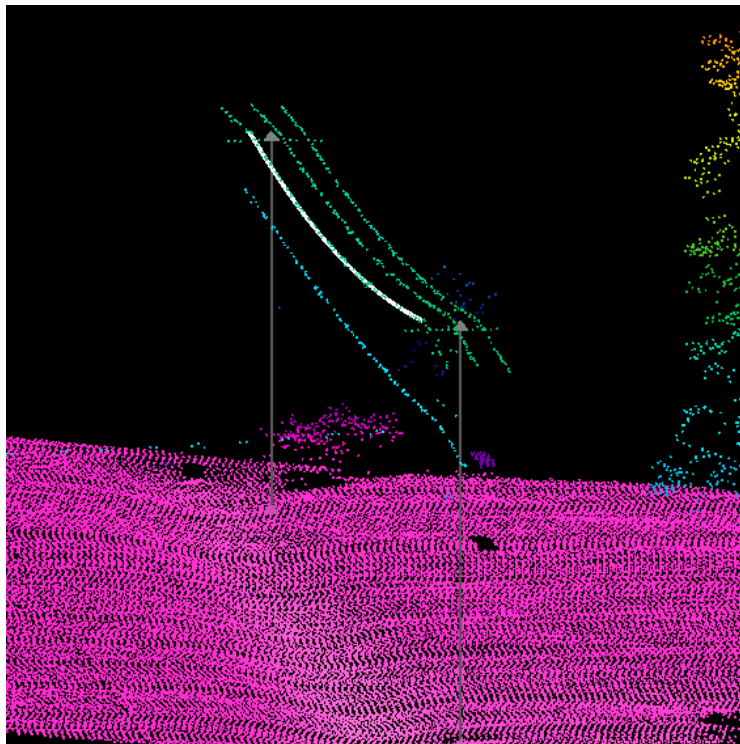
Figure 3.19 – Accepted conductor vector

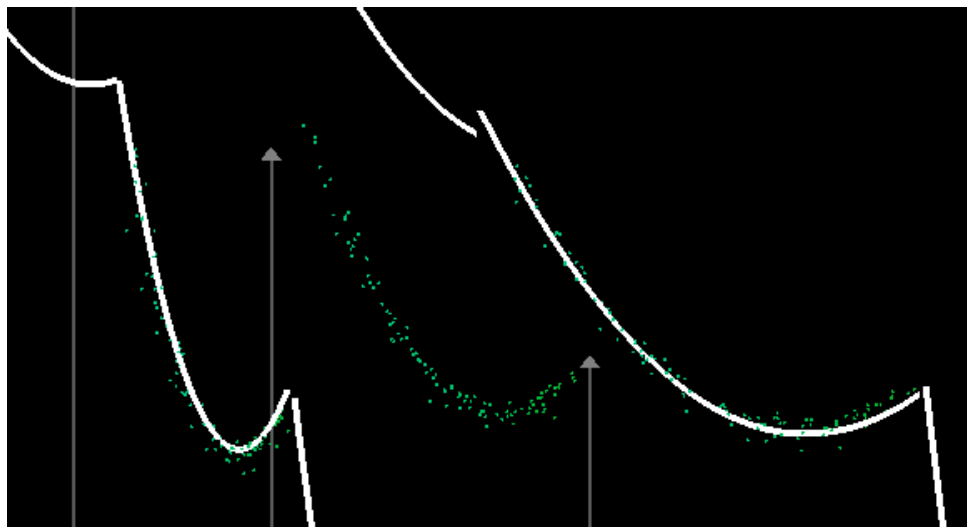
Figure 3.20 – Accepted conductor vectors

The next step was to classify the points that represented conductors in the data as something other than the vegetation classes they were originally assigned by the data vendor. To do this, vector data representing the conductors is necessary, which is why these data were extracted first. The basic idea for the reclassification of the LiDAR conductor points is that since the vector data extracted from them were a best fit to the arrangement of the points in 3D space, the vectors do not perfectly intersect every point. In other words, the LiDAR points are in a sense “floating around” the vector data in 3D space, but their proximity is still very close, within a foot (figure 3.20).

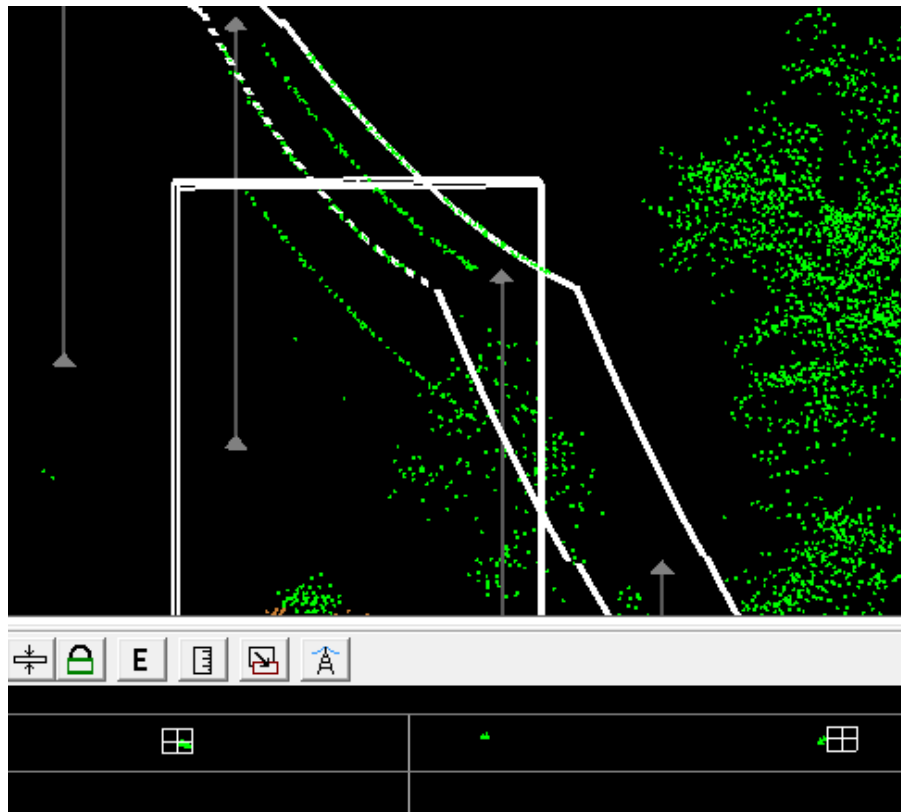
Figure 3.21 – A selected conductor vector (dashed)

A conductor span vector to be used for point classification was selected from the profile view, and it appears as a dashed line in the 3D view (figure 3.21). The box spanning across the lines is the drawn profile.

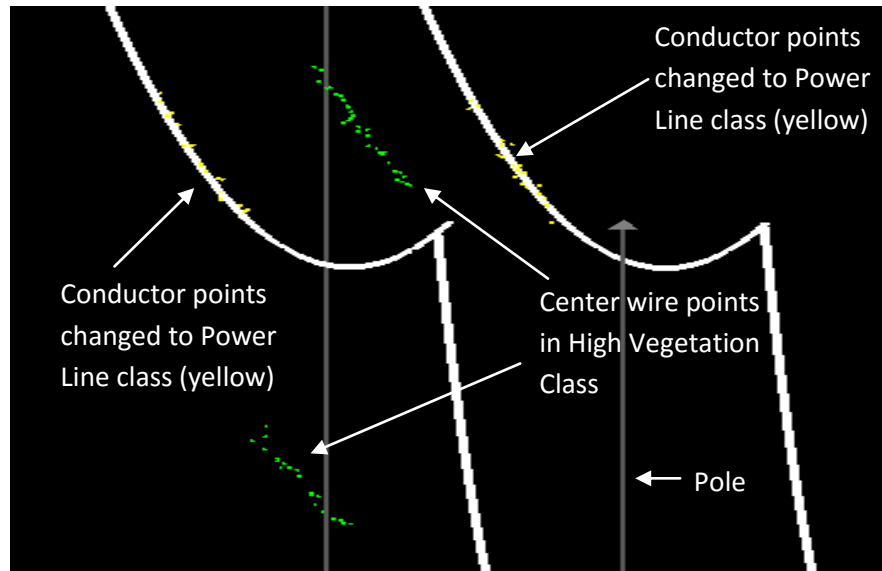
Figure 3.25 – All outer conductors classified as Power Line

A single span worth of points was first reclassified so the results could be observed before moving forward with the rest of the classification. This ensured any undesired behavior of the classification was not applied to all conductors. The buffer radius of 1.5 feet was satisfactory, so all points in the dataset within the buffers of the conductor vectors were reclassified from High Vegetation to Power Line (figure 3.25).

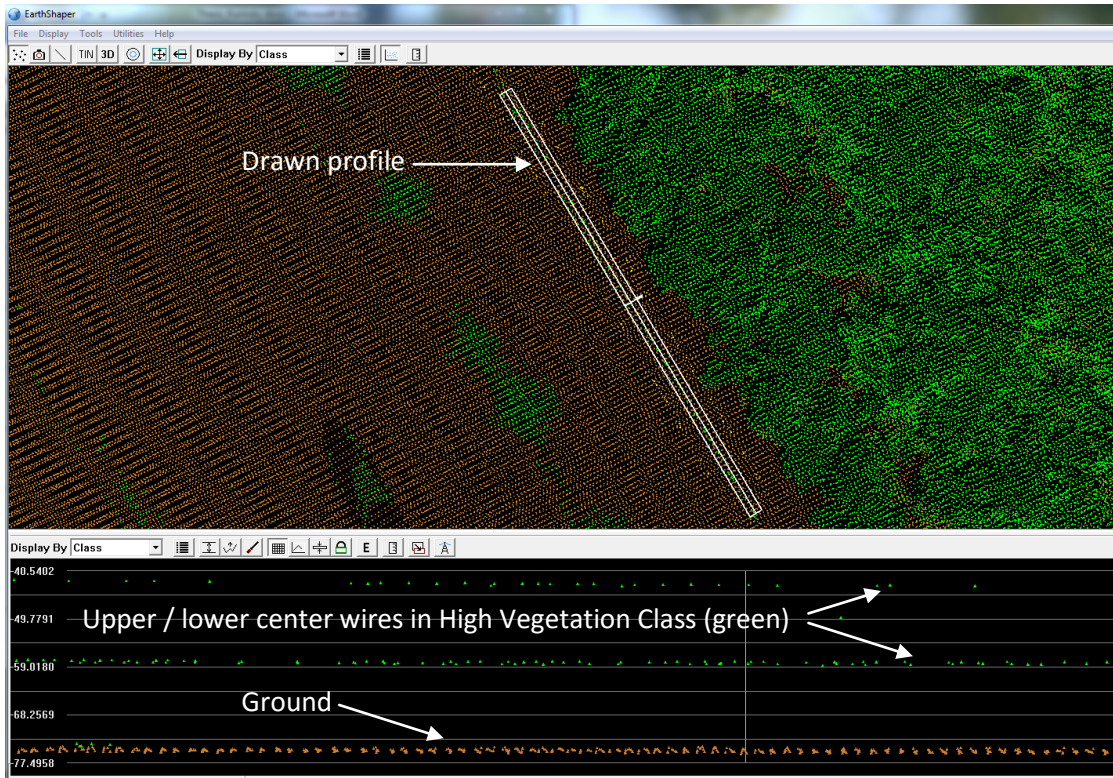
Figure 3.26 – Profile view of the center wires

A profile was drawn over the power lines narrow enough to only show the upper and lower wires in the center, between the outer wires that were already reclassified (figure 3.26). To reclassify these points throughout the dataset a tool called Polyline Edit was used. Like the other classification tools in the application, a “from” class and a “to” class had to be set (figure 3.27).

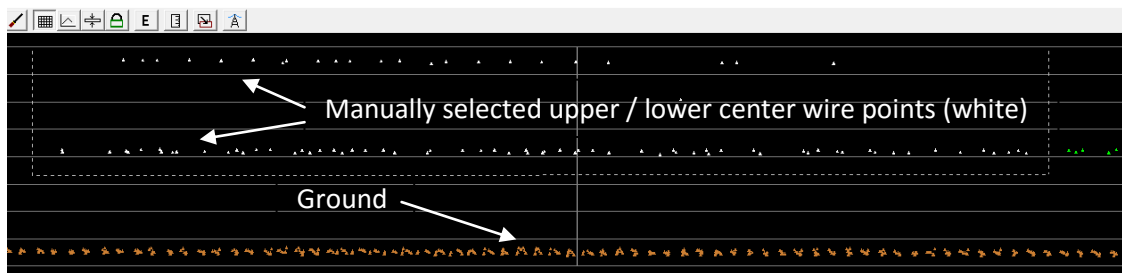
Figure 3.28 – Manually selected upper / lower center wire points (white)

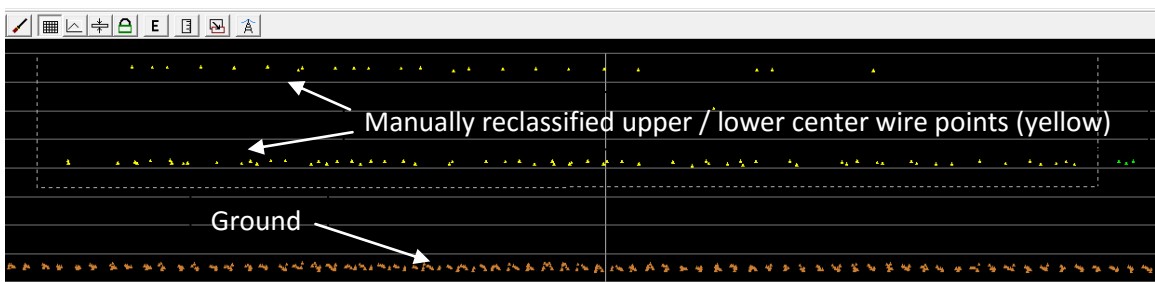
Figure 3.29 – Manually reclassified upper / lower center wire points (yellow)

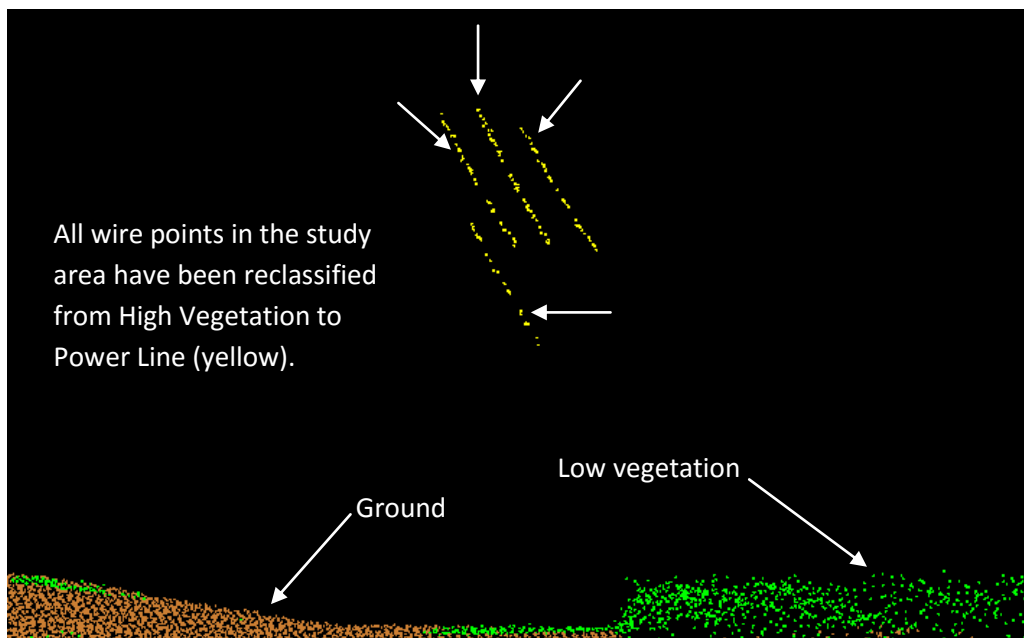
Figure 3.30 – All wire points have been reclassified to Power Line (3D view)

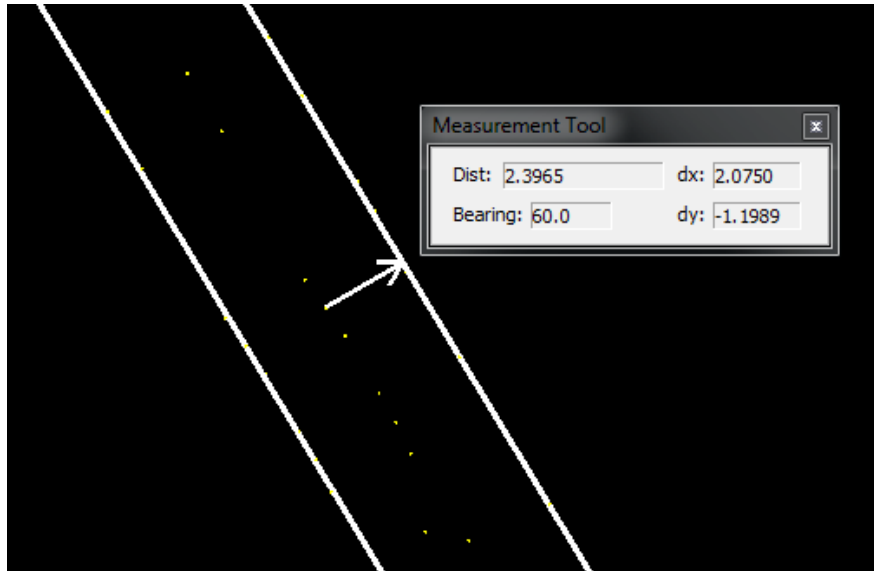
Figure 3.32 – Distance between the center and outer wires

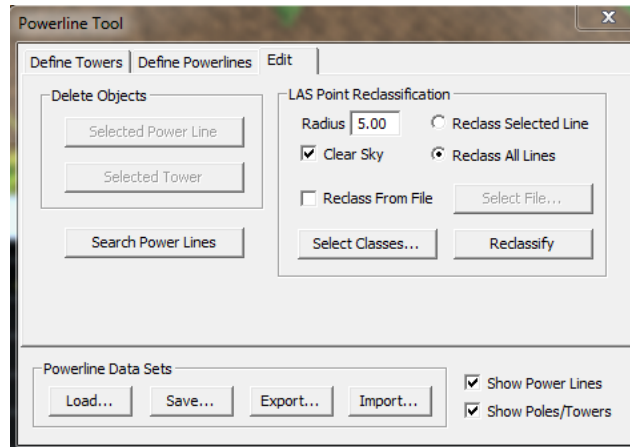
Figure 3.33 – Clear sky buffer of five feet
