POWER LINE CORRIDOR VEGETATION MANAGEMENT:
CLEARING A PATH TO RELIABLE ELECTRIC SERVICE USING LIDAR

A THESIS PRESENTED TO
THE DEPARTMENT OF HUMANITIES AND SOCIAL SCIENCES
IN CANDIDACY FOR THE DEGREE OF
MASTER OF SCIENCE

By
BRIAN KURINSKY

NORTHWEST MISSOURI STATE UNIVERSITY
MARYVILLE, MISSOURI
OCTOBER, 2013

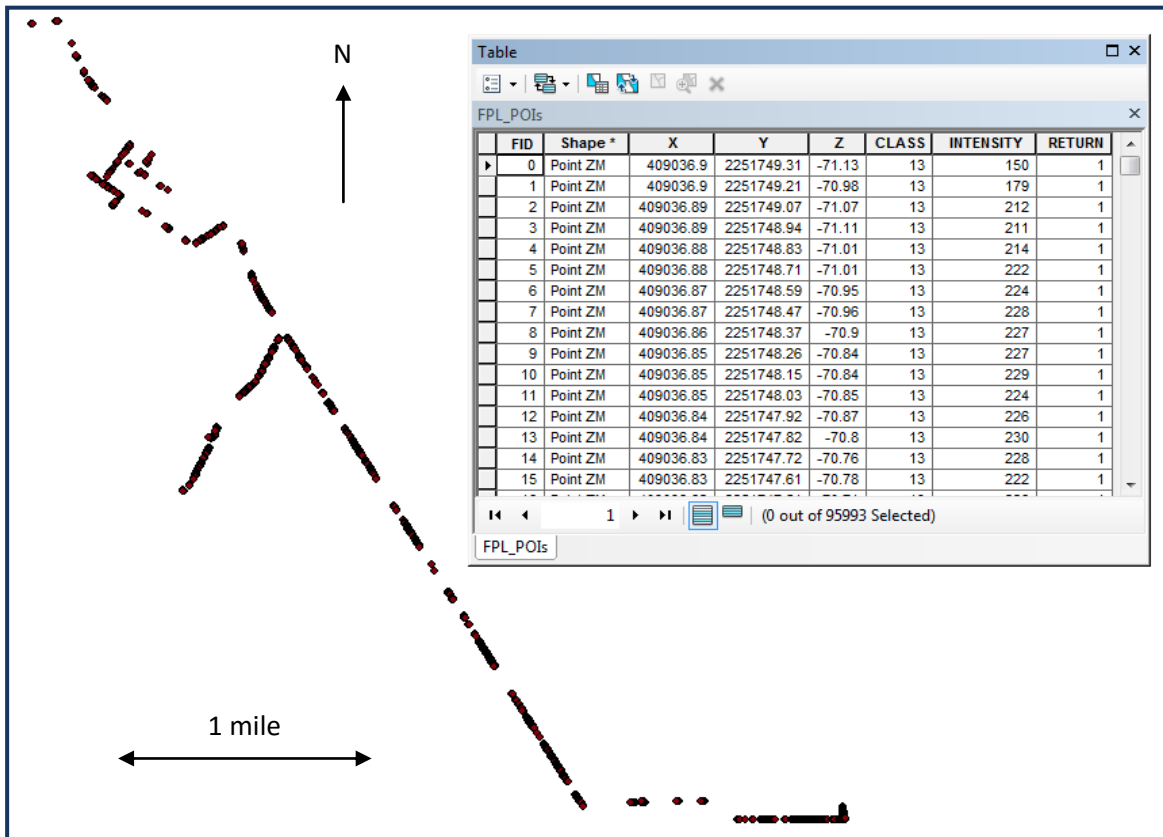
Figure 3.38 – The resulting point shapefile created from the 3D ASCII text file.

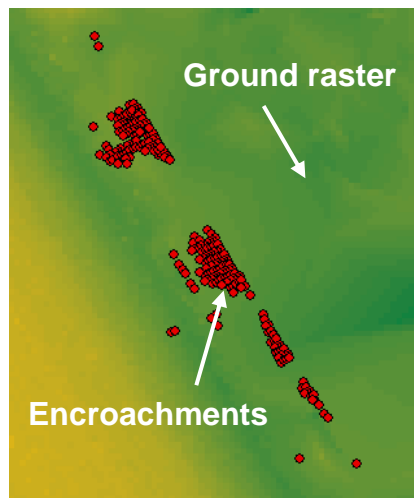
Figure 3.39 – Encroachment points over ground raster

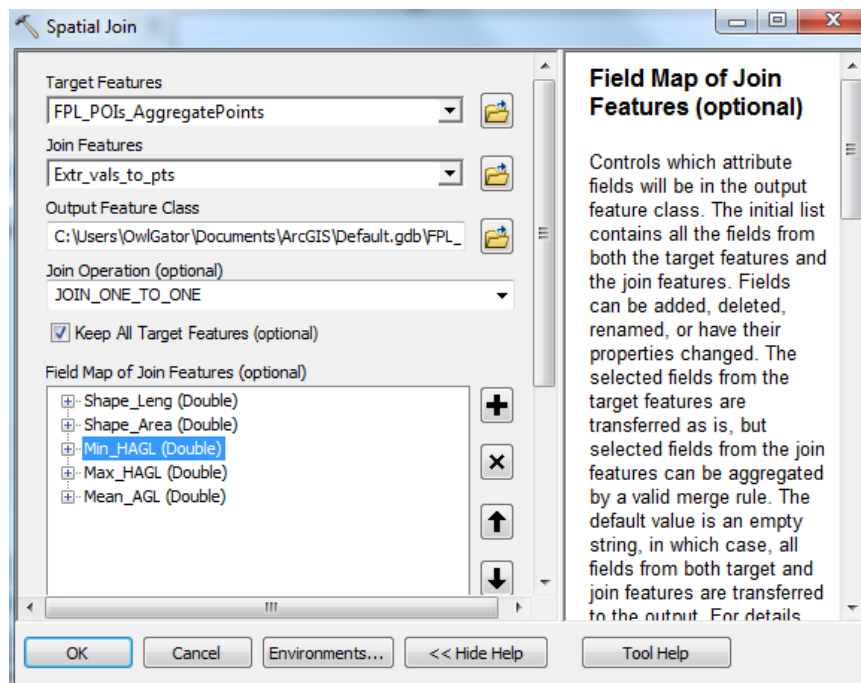
Figure 3.43 – Settings for the Spatial Join tool

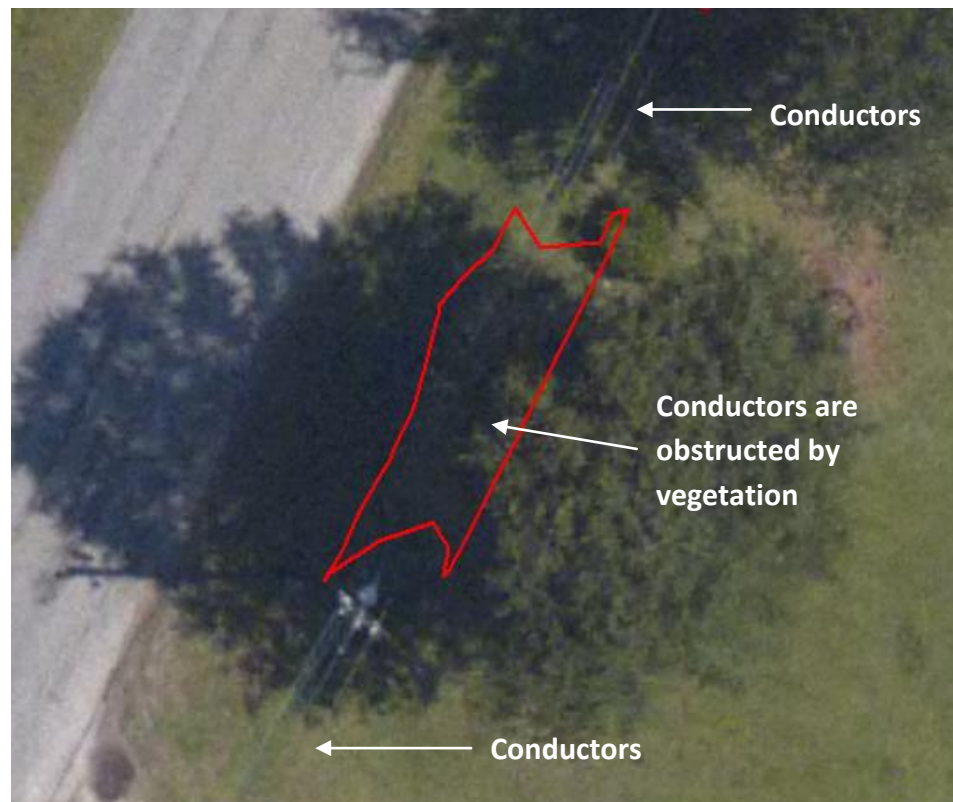
Figure 4.1 – Validated vegetation encroachments within a polygon

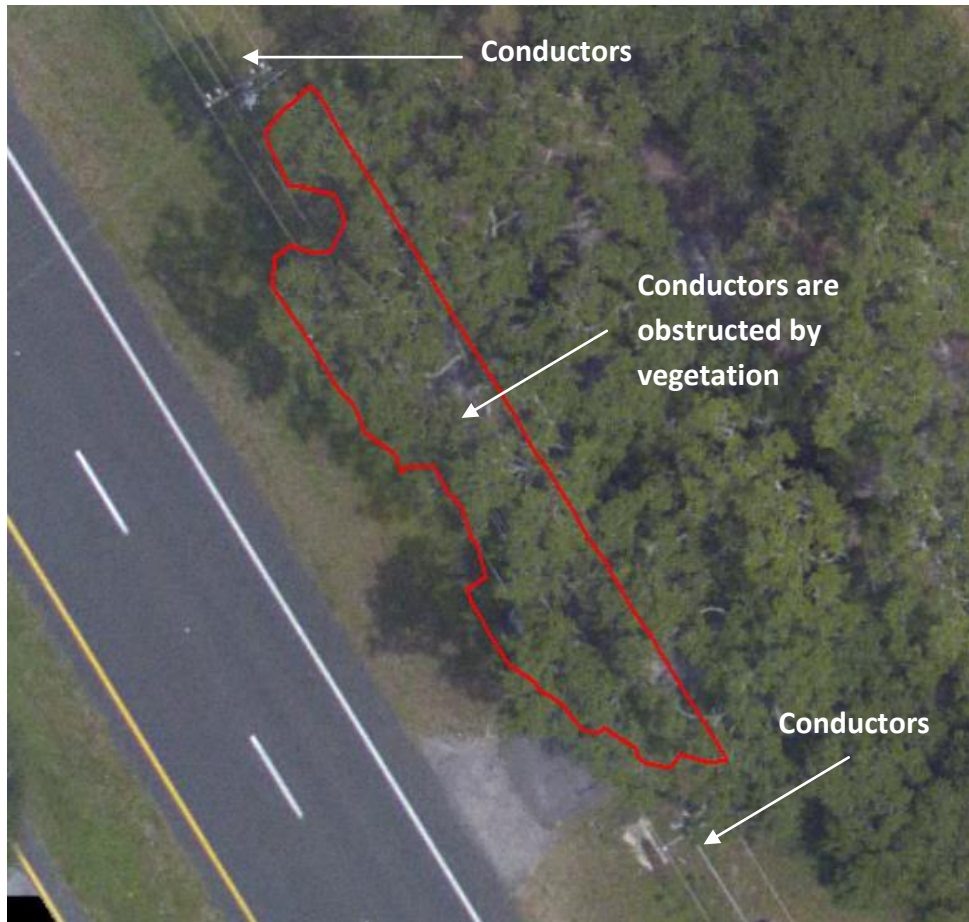
Figure 4.2 – Validated vegetation encroachments within a polygon

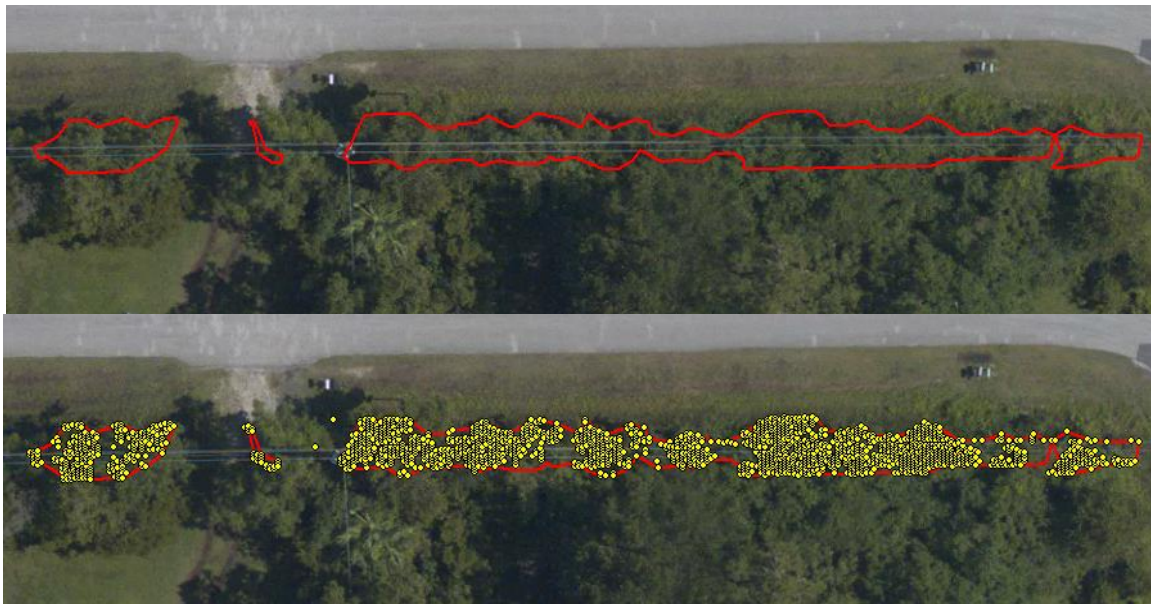
Figure 4.3 – Validated vegetation encroachments within a polygon

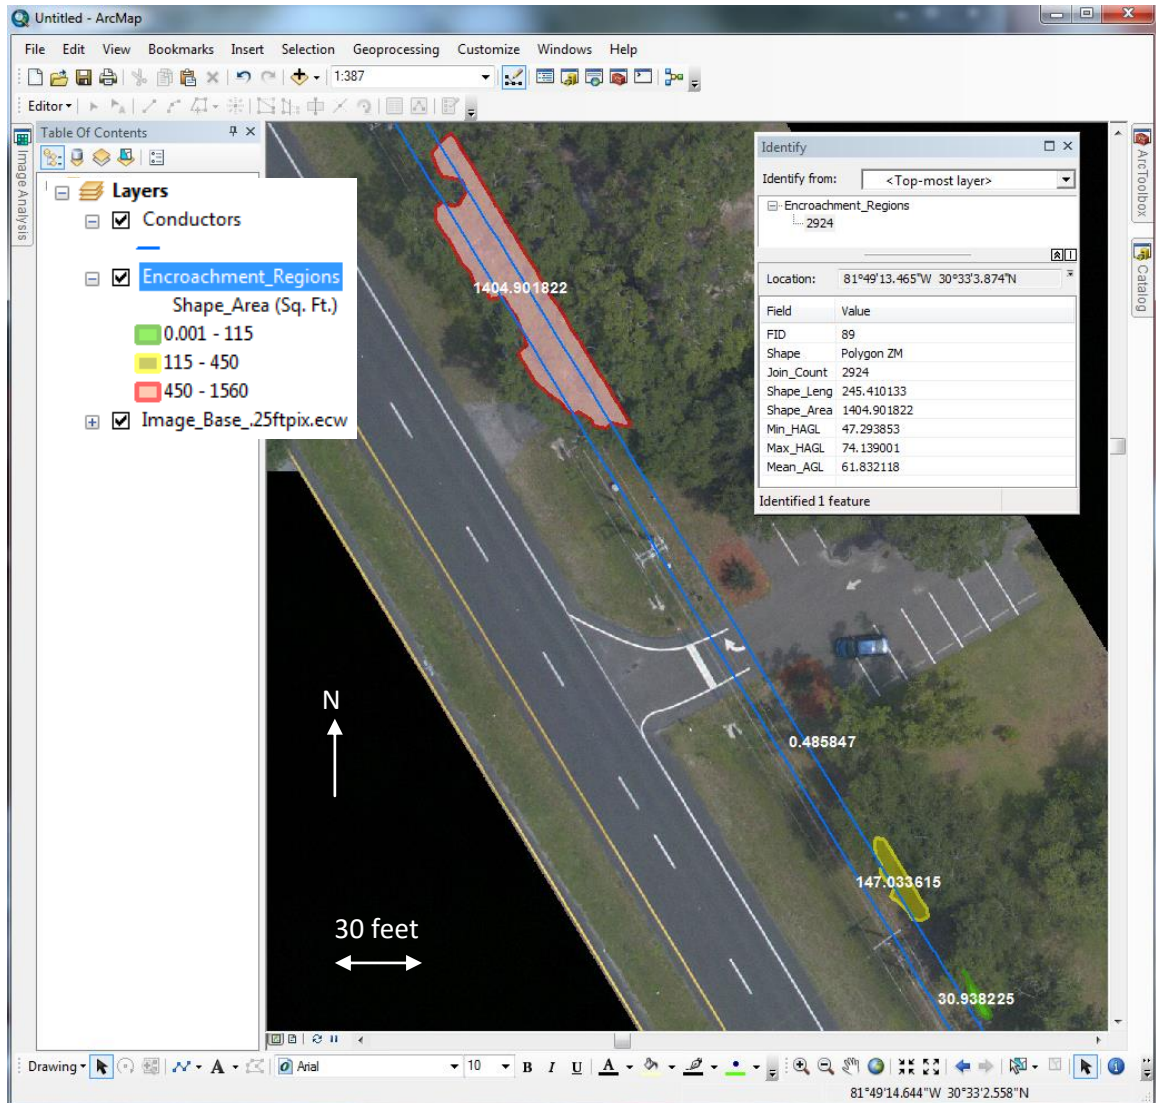
Figure 4.4 – Vegetation encroachment polygons labeled and symbolized by area

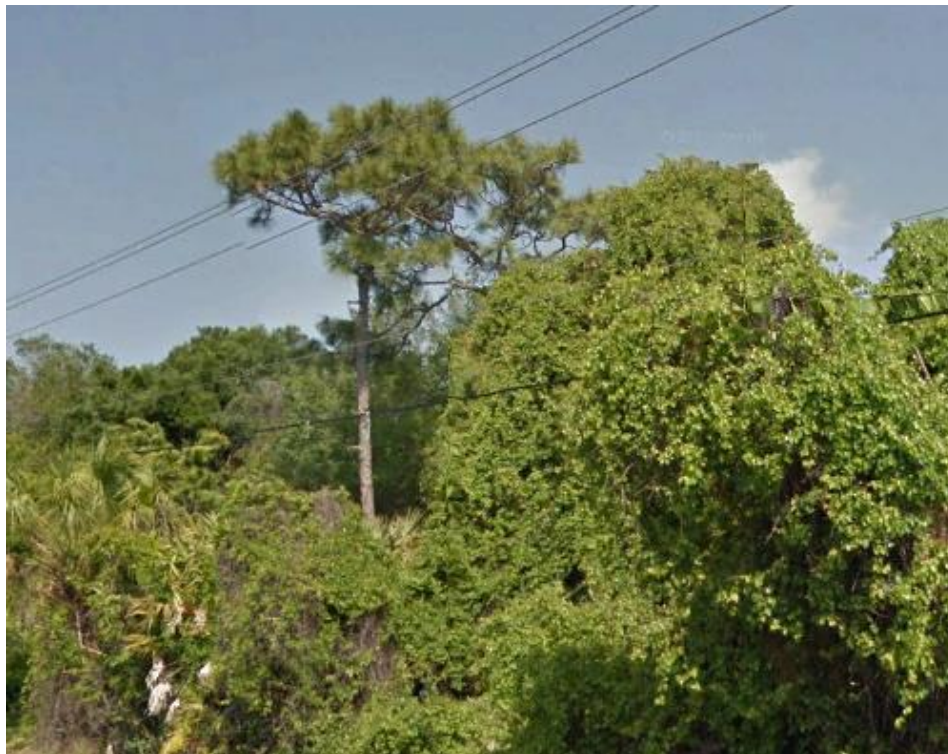
Figure 5.1 – Encroaching vegetation in the neighborhood (Google Earth)

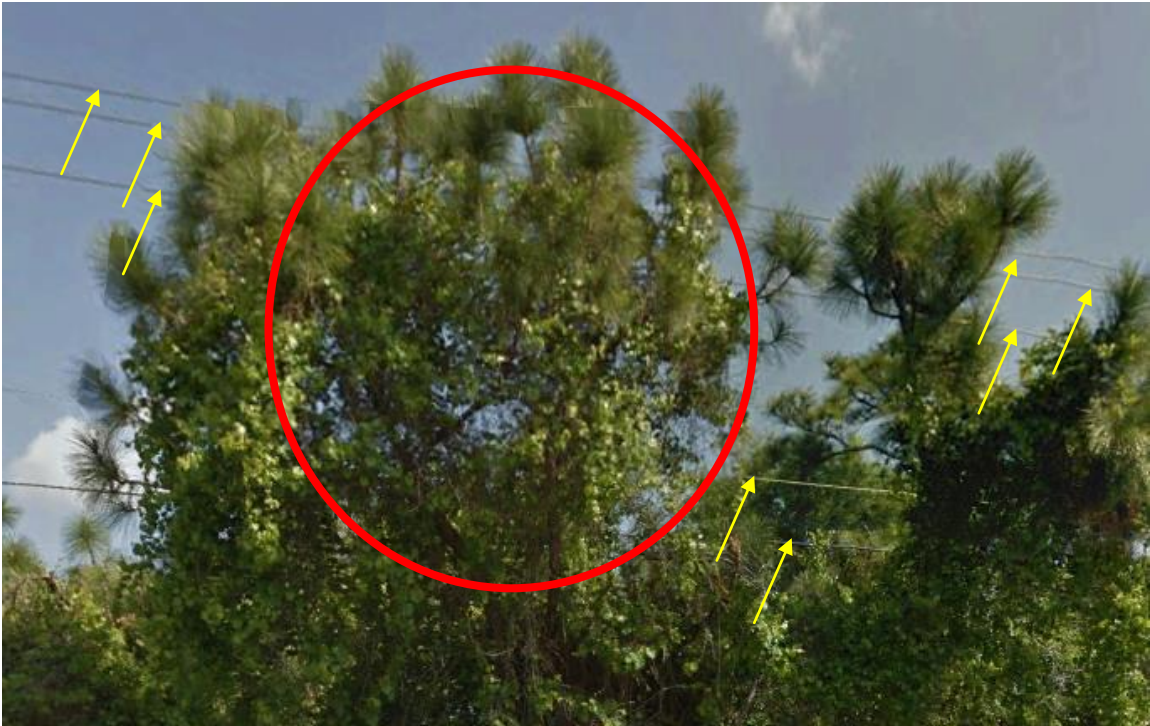
Figure 5.2 – Encroaching vegetation in the neighborhood (Google Earth)
