USING REMOTELY SENSED IMAGES TO ASSESS
ABANDONED MINE LAND RECLAMATION

A THESIS PRESENTED TO
THE DEPARTMENT OF HUMANITIES AND SOCIAL SCIENCES
IN CANDIDACY FOR THE DEGREE OF
MASTER OF SCIENCE

NORTHWEST MISSOURI STATE UNIVERSITY
MARYVILLE, MISSOURI
SEPTEMBER 2013

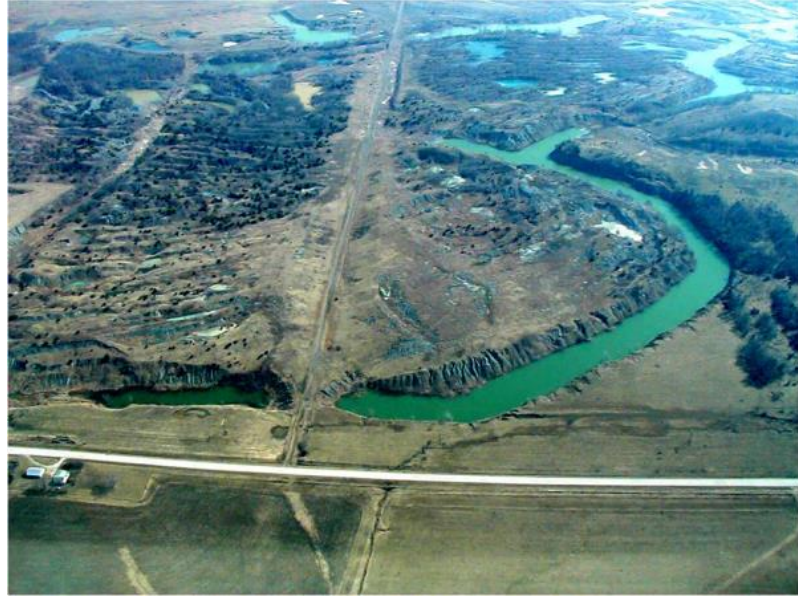
Figure 2 – Aerial photo of a portion of the study area prior to reclamation (Missouri Department of Natural Resources 2001)

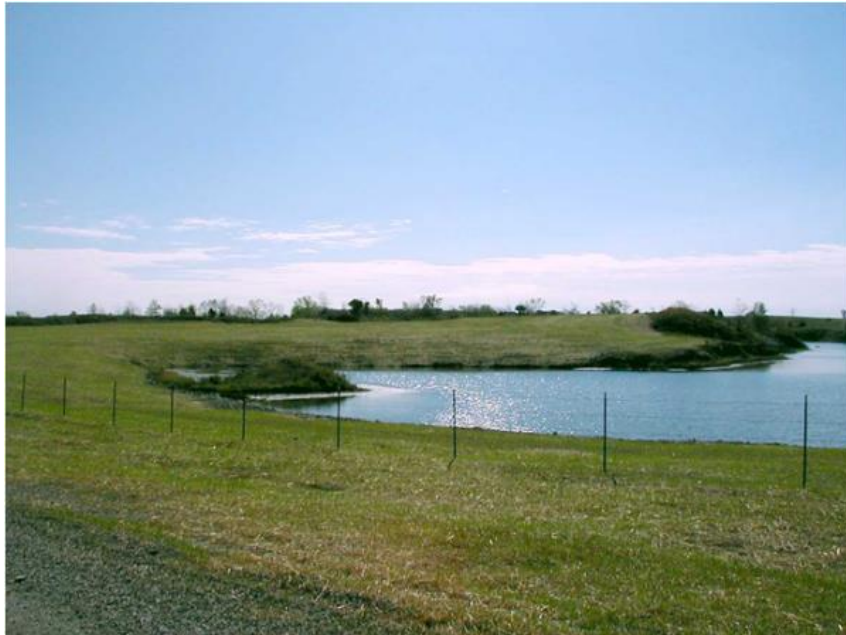
Figure 3 – Photo of the Noah Reclamation Project after grading and revegetation (Missouri Department of Natural Resources 2003)

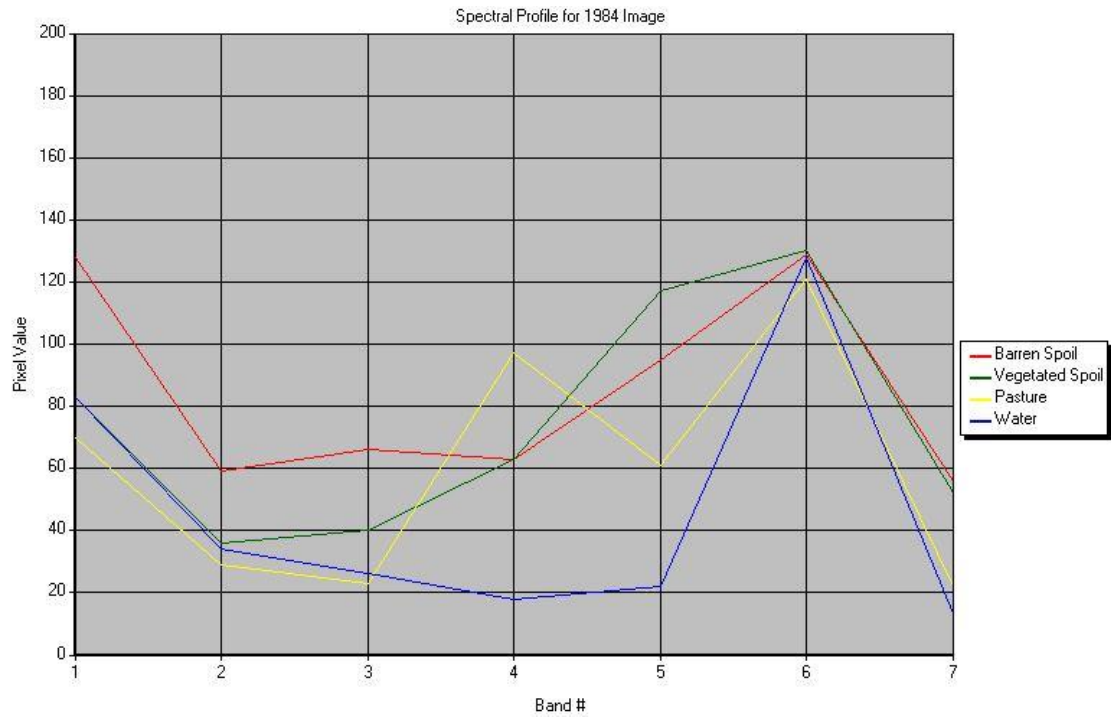
Figure 4 – Spectral profile of the 1984 image

water. The barren spoil class represents areas where mining has occurred, spoil material is exposed and there is no vegetation. The vegetated spoil class also represents areas where mining has occurred, but the spoil material is not exposed. Vegetation in these areas are generally forested, as pasture and other grasses do not readily grow on unreclaimed spoil material. The pasture class consists of grass covered areas where either no mining has ever occurred, or reclamation has been completed. The water class represents water bodies, most of which have been created by mining activities. The spectral display appearance (RGB 4/3/2) of the four classes are summarized in Table 1. The spectral profiles of all seven bands for each class are displayed in Figures 4 and 5.

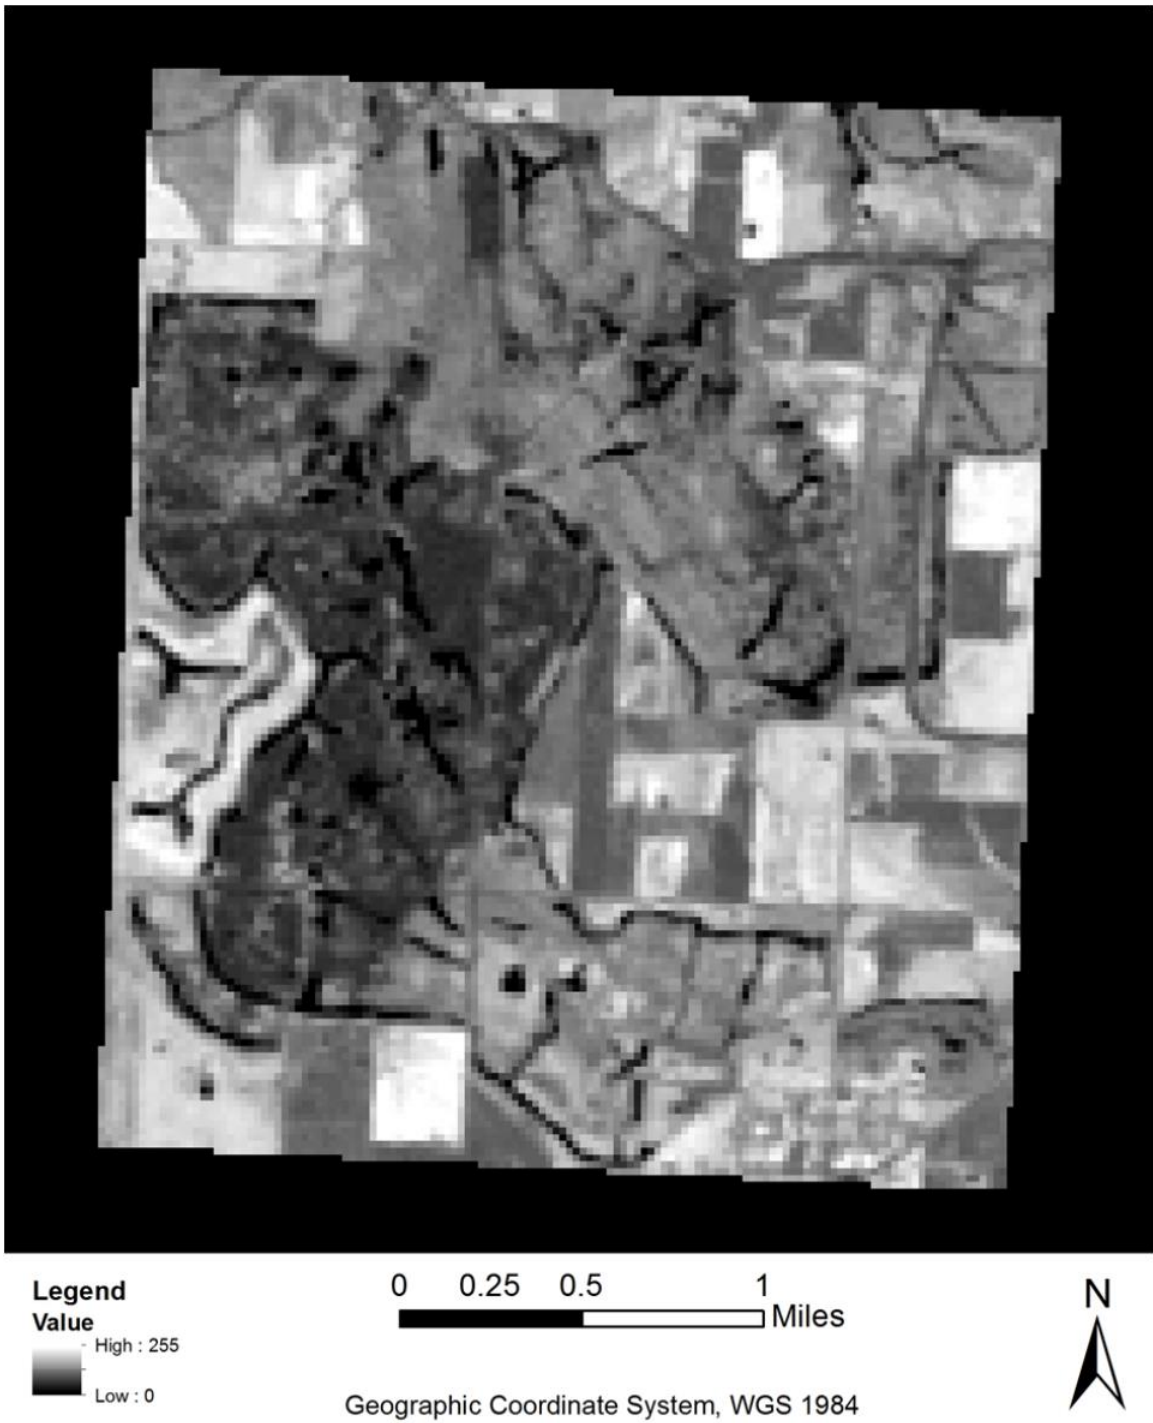
Figure 18 – NDVI image created from the 1984 Landsat TM image

Results of the NDVI analysis indicate that there are larger areas of unhealthy vegetation in the 1984 image compared to the 2011 image (Figures 18 and 19). This is apparent due to the larger areas of low-value pixels in the NDVI image from 1984 compared to the relatively smaller areas of low-value pixels in the 2011 NDVI image. The darkest areas of both images are waterbodies and were not considered when comparing the images. The relationship between the 1984 and 2011 NDVI images can be more clearly visualized when the images are symbolized by two categories. Figures 20 and 21 symbolize all NDVI values in two categories: less than 100 and greater than 100. This comparison indicates that the overall vegetative health within the study area has improved.

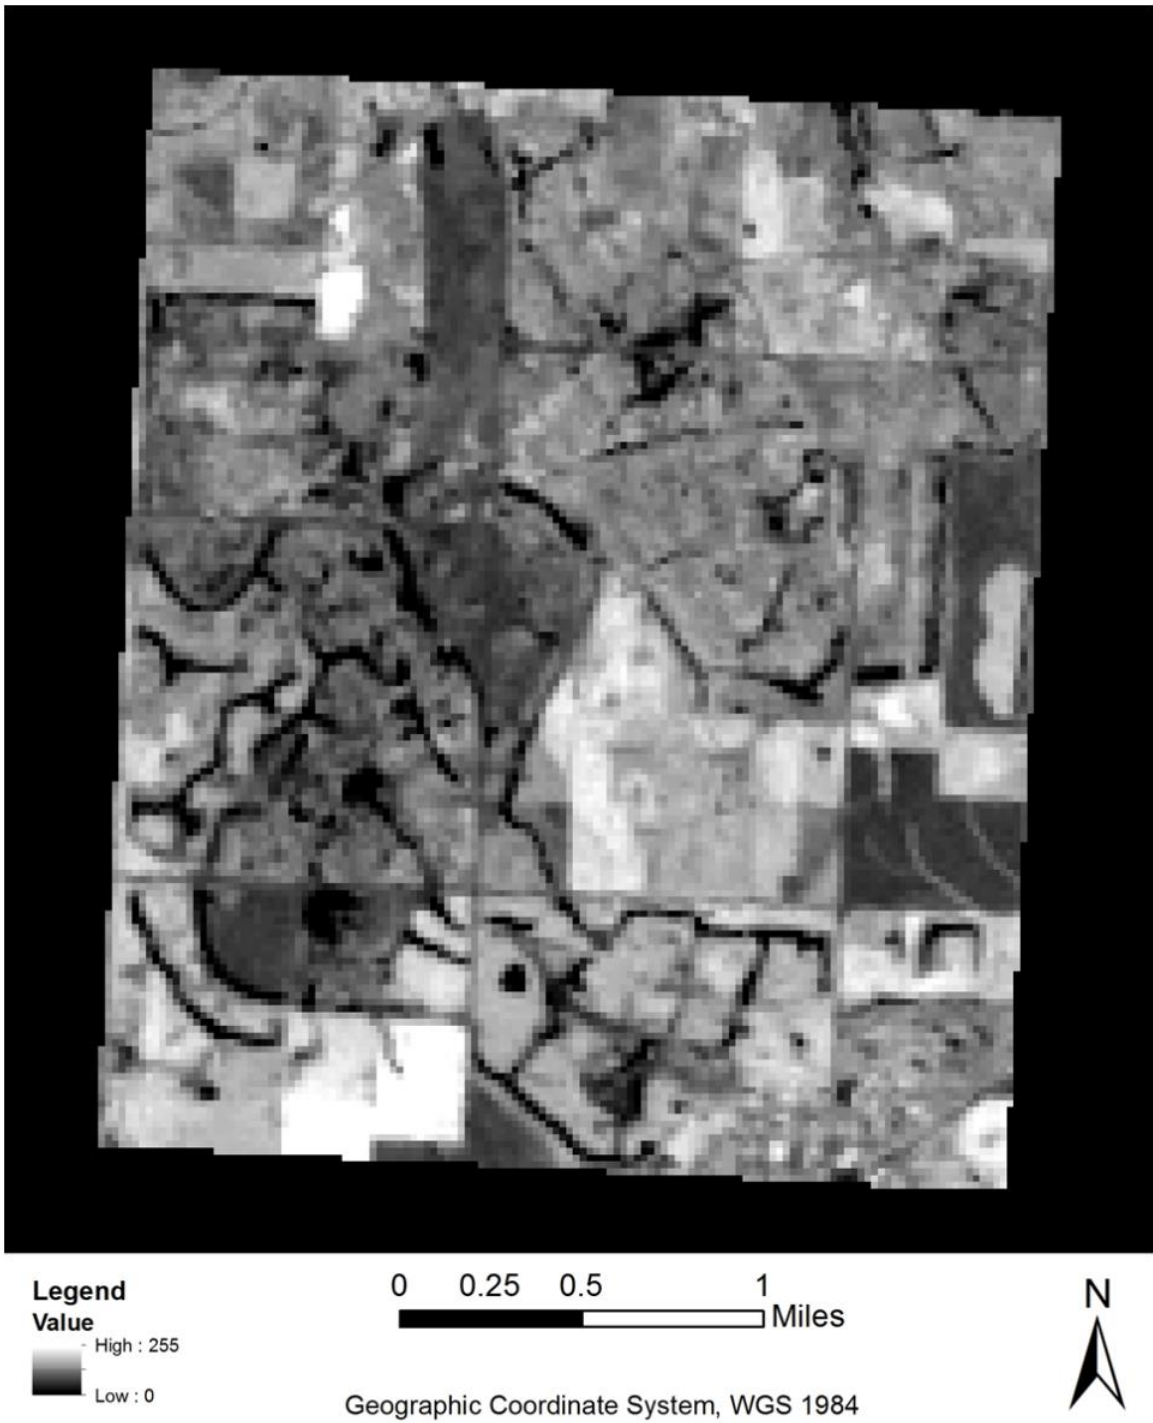
Figure 19 – NDVI image created from the 2011 Landsat TM image
